## 16-Bit MCU with 512K Byte FLASH and 18K Byte RAM Memories

ERRATA SHEET

This errata sheet describes the functional and electrical problems known in the revision AB of the ST10F280-AB engineering samples.

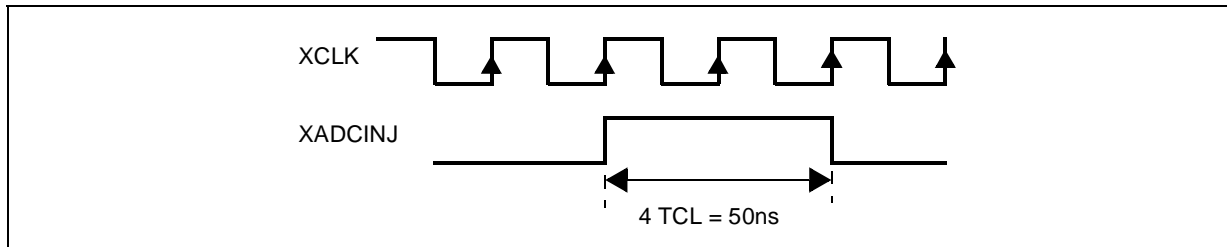
**Figure 1 : XADCINJ Timing**

The duration of the XADCINJ output lasts two cycles (50ns at 40MHz) but to ensure that a signal transition is properly recognized, an external capture input signal should be held for at least 8 CPU clock cycles before it changes its level so the duration of the XADCINJ signal is too short.

The falling edge of the XADCINJ signal must be delayed up to 8 CPU clock cycles.
