PM7364 FREEDM-32

REVISION D AND E DEVICE ERRATA

Issue 6: November, 2001

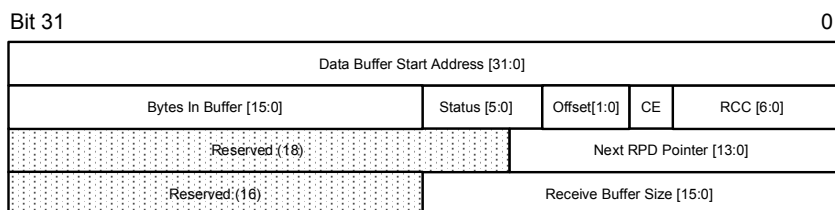
Figure 2.1: Receive Packet Descriptor.

When ALL of the following conditions are met:

1. The offset[1:0] field of a Receive Packet Descriptor (RPD) is non-zero.
2. The STRIP bit of register "**0x204 RHD L Indirect Channel Data Register #1**" is logic one.
3. The incoming packet payload is smaller than the FCS field (2 bytes for CRC-CCITT or 4 bytes for CRC-32).

The value in the "Bytes in Buffer [15:0]" field of the RPD can be underflowed. That is, this field will contain a negative value. If this field is interpreted as an unsigned integer, the content of the buffer can be erroneously interpreted as a very large number.

If the "Bytes in Buffer" field is interpreted as a very large number, the driver software may attempt to read data from outside of the allocated buffer space.

1. If the Offset[1:0] bits of RPD are set to zero, this problem will not occur.
2. If the STRIP field of "**0x204 RHD L Indirect Channel Data Register #1**" is set to zero, this problem will not occur.
3. If the buffer size is not larger than 32K Bytes, the most significant bit of the "Byte in Buffer" field can be used as a sign bit. The device software should discard RPDs that contain a negative "Bytes in Buffer" value.
4. For every RPD, the driver software can compare the "Bytes in Buffer[15:0]" field to ensure that it is smaller than or equal to "Receive Buffer Size[15:0]".

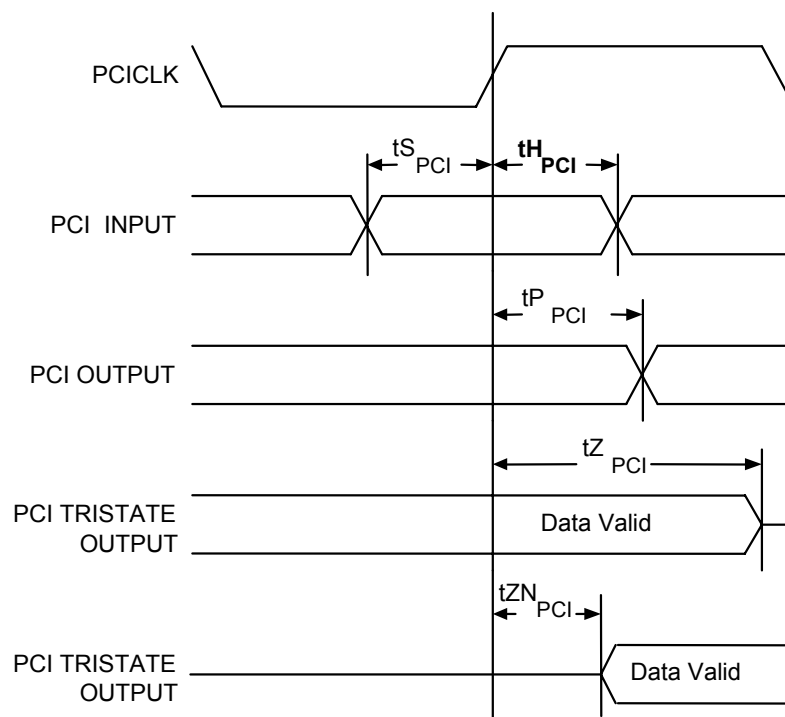
Figure 2.2: PCI Interface Timing

PCI Input and Bi-directional signals require a minimum hold time ($t_{H_{PCI}}$) of 1 ns with respect to PCICLK.

If the clock skew is not kept within the above limit, FREEDM-32 may operate incorrectly.

The PCI 2.1 specification requires PCI outputs to have a minimum 2 ns propagation delay. The clock skew between FREEDM-32 and other PCI devices in a system must therefore be kept below 1 ns to ensure correct operation.

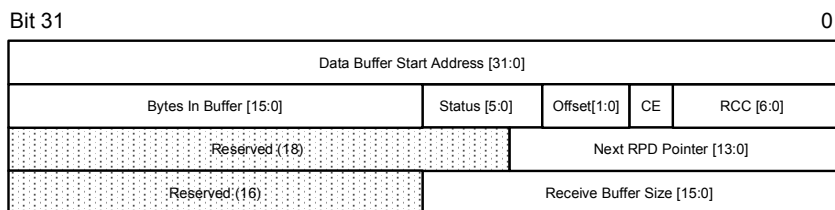
Figure 3.1: Receive Packet Descriptor.

The Receive Buffer Size [15:0] field of the RPD was incorrectly specified in the FREEDM-32 Datasheet.

Field	Description
Receive Buffer Size [15:0]	The Receive Buffer Size [15:0] bits indicate the size in bytes of the current RPD's data buffer. This field is expected to be configured by the Host during initialization. <u>The Receive Buffer Size must be a non-zero integer multiple of four and less than or equal to 32764.</u> The Receive Buffer Size is valid in all RPDs.

Field	Description
Receive Buffer Size [15:0]	The Receive Buffer Size [15:0] bits indicate the size in bytes of the current RPD's data buffer. This field is expected to be configured by the Host during initialization. The Receive Buffer Size must be a non-zero integer multiple of four and less than or equal to 32764. <u>The Receive Buffer Size must be a non-zero integer multiple of 16 and less than or equal to 32752.</u> The Receive Buffer Size is valid in all RPDs.
