PM7366 FREEDM-8

REVISION D AND E DEVICE ERRATA

Issue 7: November 2001

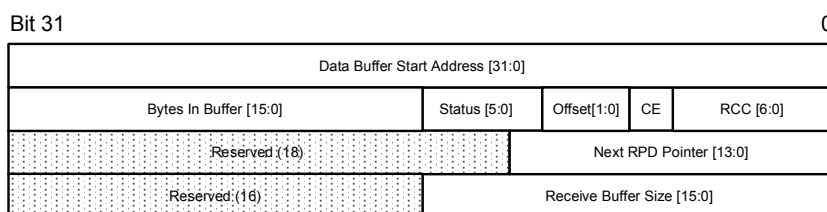
Figure 2.1: Receive Packet Descriptor.

When ALL of the following conditions are met:

1. The offset[1:0] field of a Receive Packet Descriptor (RPD) is non-zero.
2. The STRIP bit of register "**0x204 RHDL Indirect Channel Data Register #1**" is logic one.
3. The incoming packet payload is smaller than the FCS field (2 bytes for CRC-CCITT or 4 bytes for CRC-32).

The value in the "Bytes in Buffer [15:0]" field of the RPD can be underflowed. That is, this field will contain a negative value. If this field is interpreted as an unsigned integer, the content of the buffer can be erroneously interpreted as a very large number.

If the "Bytes in Buffer" field is interpreted as a very large number, the driver software may attempt to read data from outside of the allocated buffer space.

1. If the Offset[1:0] bits of RPD are set to zero, this problem will not occur.
2. If the STRIP field of "**0x204 RHDL Indirect Channel Data Register #1**" is set to zero, this problem will not occur.
3. If the buffer size is not larger than 32K Bytes, the most significant bit of the "Byte in Buffer" field can be used as a sign bit. The device software should discard RPDs that contain a negative "Bytes in Buffer" value.
4. For every RPD, the driver software can compare the "Bytes in Buffer[15:0]" field to ensure that it is smaller than or equal to "Receive Buffer Size[15:0]".

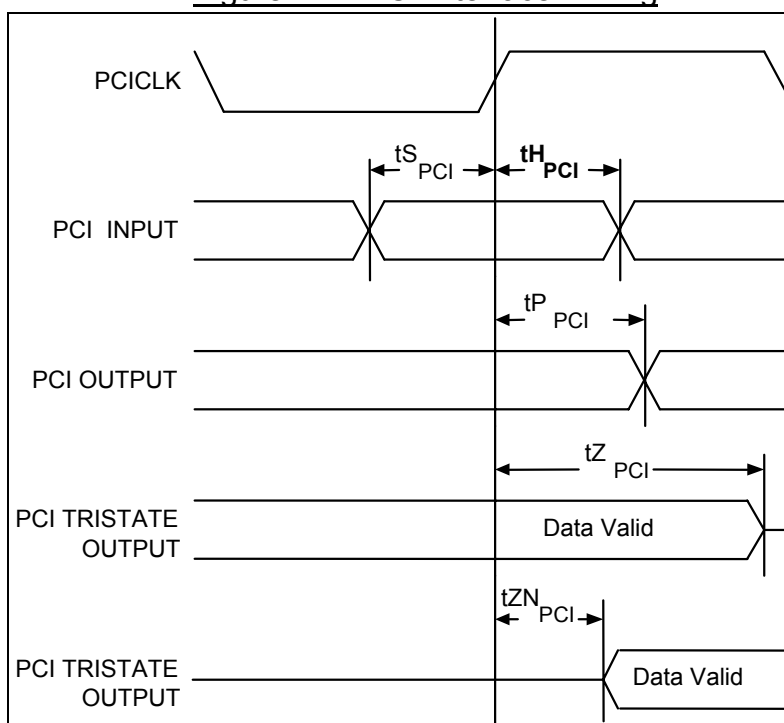
Figure 2.2: PCI Interface Timing

PCI Input and Bi-directional signals require a minimum hold time ($t_{H_{PCI}}$) of 1 ns with respect to PCICLK.

If the clock skew is not kept within the above limit, FREEDM-8 may operate incorrectly.

The PCI 2.1 specification requires PCI outputs to have a minimum 2 ns propagation delay. The clock skew between FREEDM-8 and other PCI devices in a system must therefore be kept below 1 ns to ensure correct operation.
