PM4351 COMET

COMET DATASHEET ERRATA

COMET REV. E AND REV. F

ISSUE 12: OCTOBER 2000

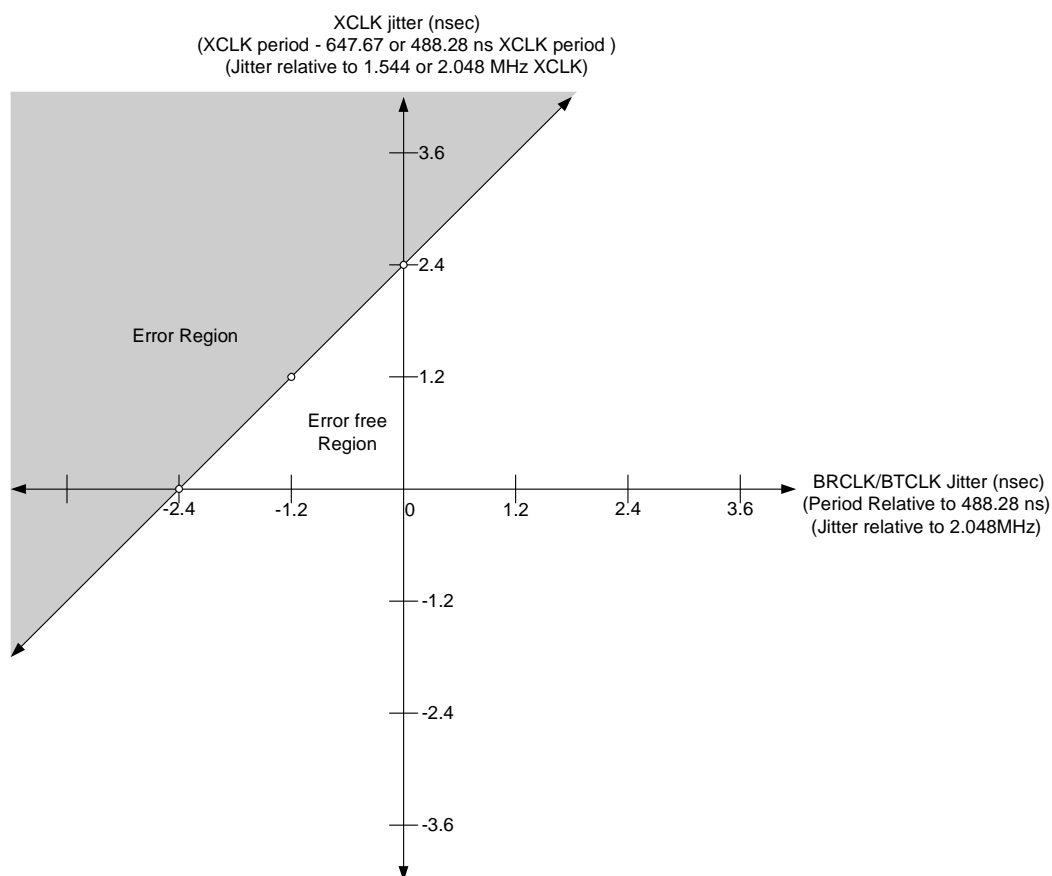
When the COMET is configured for T1 mode with a slaved clock backplane (BRCLK or BTCLK are inputs) with a 2.048 MHz or greater backplane rate, the data and signaling information may be corrupted if the BRCLK, BTCLK, and XCLK jitter (defined as instantaneous worse case period) is not tightly controlled. The following diagram shows the error and error-free operating regions when in the presence BRCLK/BTCLK and XCLK jitter.

The BRCLK/BTCLK jitter is described as the worst case instantaneous peak jitter relative to a jitter-free BRCLK/BTCLK. The XCLK jitter is described as the worst case instantaneous peak jitter relative to a jitter-free XCLK. The jitter for both XCLK and BRCLK/BTCLK are described as positive and negative peak jitter in nanoseconds (ns). Positive peak jitter increases the instantaneous period while negative peak jitter shortens the instantaneous period.

Note that BRCLK and BTCLK are inputs (when the COMET is a backplane slave) and can be 1.544, 2.048, 4.096, 8.192, or 16.384 MHz. If the 4.096, 8.192 or 16.384 MHz clocks are used, they are divided down internally by the COMET to become a 2.048 MHz clock. Thus, internally the period of BRCLK/BTCLK is treated as if it were either a 1.544 or 2.048 MHz clock. The above diagram represents the internally divided down BRCLK/BTCLK clocks.

Proper operation is ensured when the worst case instantaneous XCLK jitter minus the worst case instantaneous BRCLK/BTCLK jitter is less than 2.4ns through all valid voltage and temperature range (XCLK jitter – BRCLK/BTCLK jitter < 2.4). The following are example configurations that allow the COMET to operate error free.

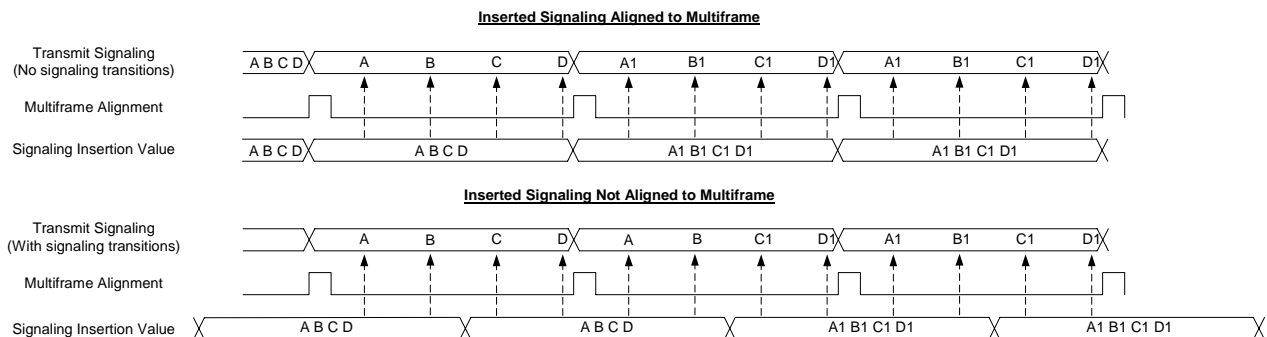
Signaling insertion could have a transitional state when the signaling state changes.

T1 signaling on the COMET is inserted relative to the multiframe alignment of the transmitted T1 signal. Signaling data is extracted bit by bit from the TPSC indirect register or the BTSIG pin. This means that each of the signaling bits (A, B for SF and A, B, C, and D for ESF) is taken from a different frame relative to the multiframe boundary. If the signaling data on the BTSIG pin (or the TPSC Indirect register) is used to insert signaling, but is not aligned to the multiframe boundary, then transitional signaling states might occur. Signaling data could change from the current signaling state to an intermediate signaling state (for 3ms or one multiframe) before changing to the correct signaling state, as shown below.

When the transmit backplane is configured for basic frame mode, the COMET assumes an arbitrary multiframe alignment. When configured for basic frame alignment, there is no way to align to the internal multiframe. Therefore transitional states for signaling might occur. Hence, it is necessary to configure the backplane for multiframe alignment to ensure signaling insertion occurs without transitional states.
