Errata: CS43L42 Rev. DCS43L42 Low Voltage, Stereo DAC with Headphone Amp

All references to the CS43L42 mentioned below shall be taken to refer to revision D of the CS43L42 product. The hardware revision code can be found in the 10-character field printed below the part number on each chip. The letter which appears as the fifth character from the right is the revision code (e.g. ZNACSD9926 is a Revision D part).

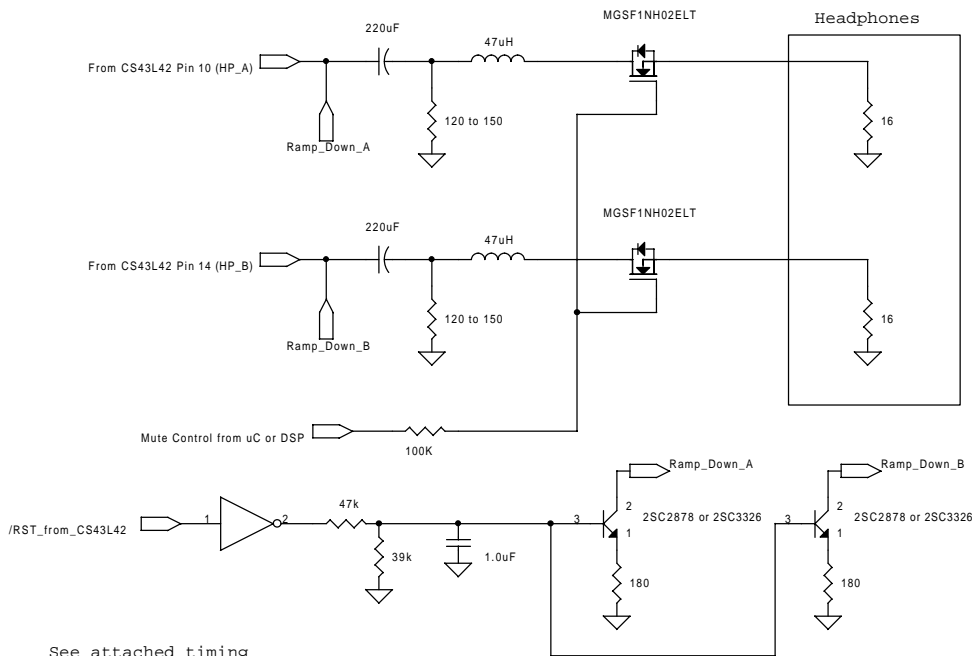
Figure 1. Pop Guard Fix

- The PopGuard[®] Transient Control does not function properly and will produce audible artifacts on the headphone and line outputs during power-up. A hardware fix is available for this issue. Please see Figures 1 and 2 for the headphone output fix. For the line outputs, please use the optional mute circuit shown in the CDB43L42 schematic to mask this problem.

- The PopGuard[®] Transient Control power-down ramp requires 5 seconds to prevent audible artifacts on the headphone outputs at the next power-up. A hardware fix is available for this issue, see Figures 1 and 2 for details. This fix will reduce the ramp down time to approximately 300 milliseconds.

The Motorola MOSFETs shown have been tested to work properly, however, an equivalent device may be used.

See attached timing diagram for /RST and the Mute control. Customer will need to generate the mute control from their DSP or micro-controller.

2SC2878 is in TO-92 package
2SC3326 is in SOT-23 package

The Toshiba transistors or equivalent will work best here. The device used must have a very low R_{on} (3 ohms or less).
