Mask Set Errata for Mask 3K45H

This mask set errata applies to the mask 3K45H for these products:

- MC68HC908JB8

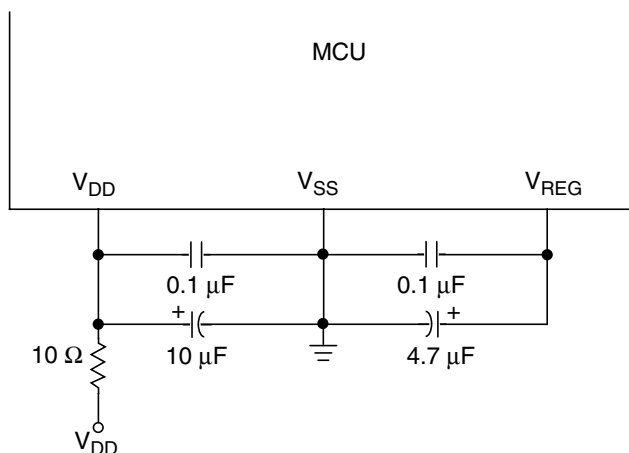
A few devices start abnormally during power-up. The issue is the release of the low voltage reset (LVR) earlier than the V_{REG} reaching the CMOS logic operating voltage (typical 0.65 V).

The LVR takes the V_{DD} but not the V_{REG} as a reference. LVR exists until the V_{DD} reaches the LVR threshold voltage (V_{LVR}). The problem happens in few devices when the V_{DD} rises quickly and the V_{REG} rises slowly. If the LVR has been released but the V_{REG} doesn't reach the CMOS logic operating voltage, the LVR does not have any effect. This might cause the internal logic to improperly initialize and the MCU might not start normally.

Therefore, the V_{DD} voltage must be lower than the VLVR minimum (2.8 V) when the V_{REG} voltage reaches the CMOS logic operating voltage.

To fix the problem, add a 10 Ω series resistor between the power supply and the V_{DD} , and place a 10 μF capacitor at the V_{DD} pin and a 4.7 μF capacitor at the V_{REG} pin.

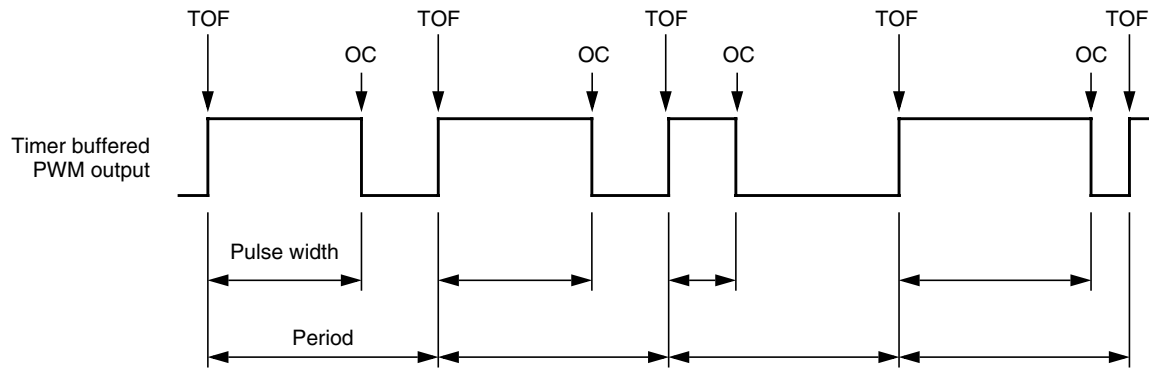
In timer buffered PWM operation, when a timer overflow (TOF) event or an output compare (OC) event coincides with a write to either pair of the timer channel registers (TCHxH/L), the duty cycle at the PWM output glitches to 0% or 100% momentarily, then returns to proper operation.

To avoid the glitches when changing the PWM duty cycle, do not write to either pair of the timer channel registers at the TOF or OC.

For example, in the TOF interrupt service routine: If the OC occurs near the last TOF, write to the timer channel registers after the OC; if the OC occurs near the next TOF, write to the timer channel registers before the OC. A write to the channel register high byte (TCHxH) should immediately followed by a write to the low byte (TCHxL) to avoid TOF or OC occurring between the writes. Instruction cycle times must be included when making timing calculations.

Do not write to either pair of timer channel registers at:
 TOF (timer overflow), or
 OC (timer output compare) edges.
