Errata on AT91SAM9G45 Engineering Sample Devices

AT91 ARM Thumb-based Microcontrollers

AT91SAM9G45

Errata Sheet

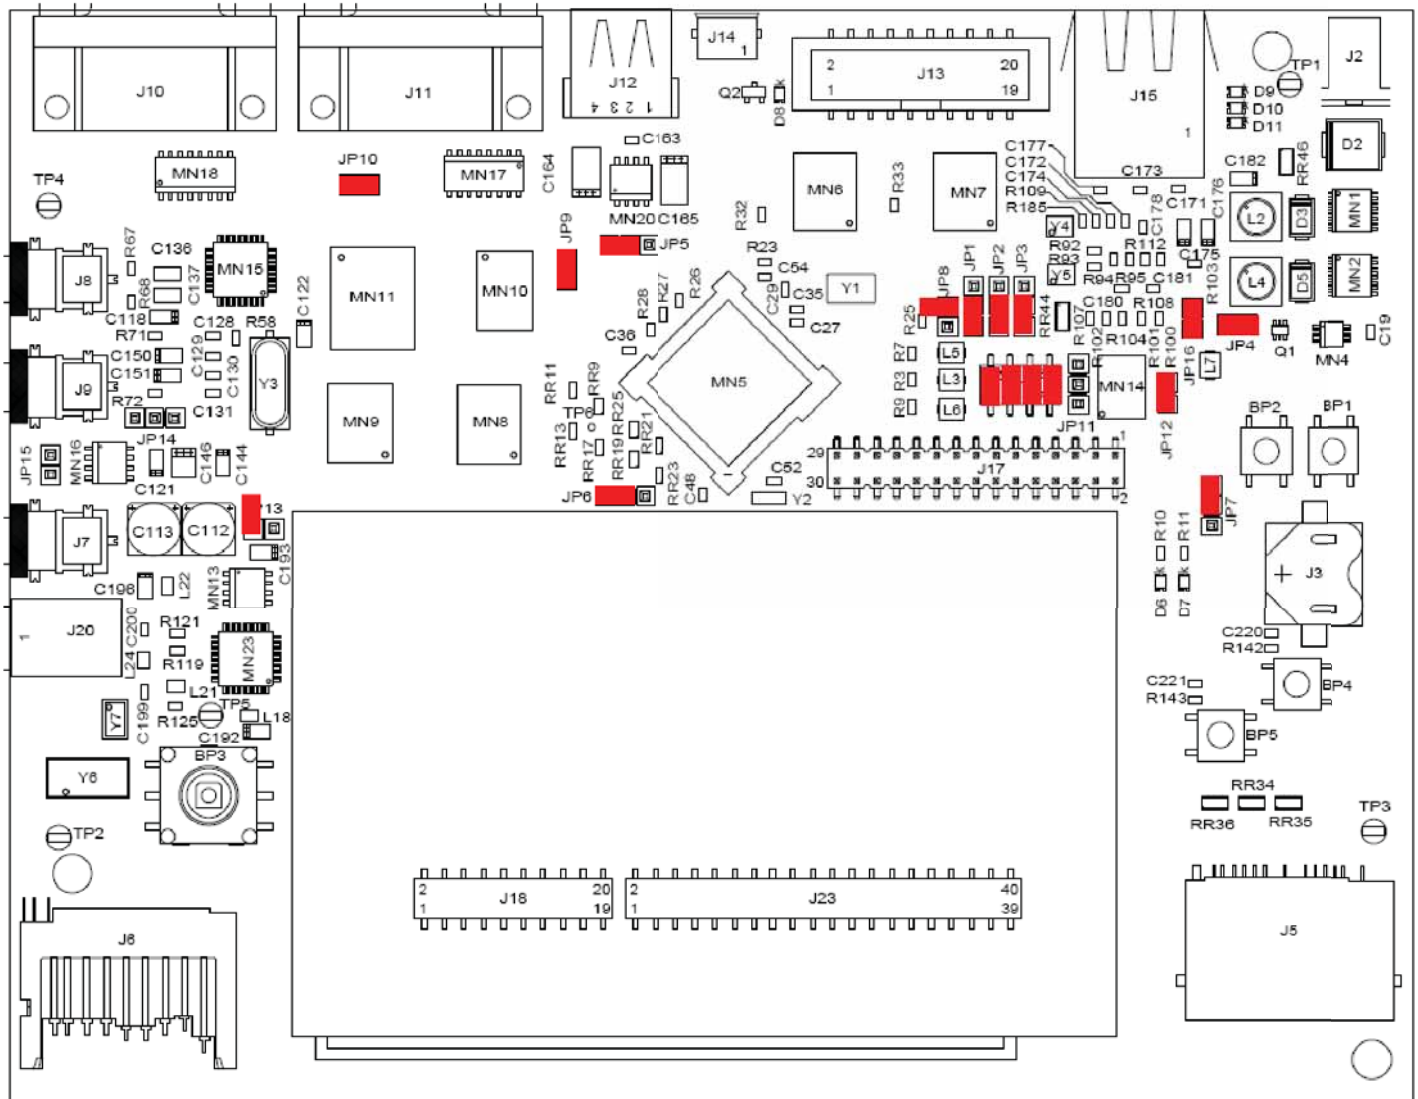
Figure 2-1. Default Jumpers Settings

The connection through USB to the SAM-BA monitor does not work.

2.3.2 AT91SAM9G45-ES ROM Code Replacement

Prior to any operation, the user needs to install *AT91-ISP.exe 1.13* and unzip [AT91SAM9G45_RomCode_Replacement.zip](#) file that contains a version of ROM binary code with USB issue fixed. Check and conform to the following Default Jumpers Settings.

1. unplug power supply
2. unplug USB device cable
3. remove jumper JP10 (NandFlash Chip Select) & JP12 (DataFlash Chip Select)
4. plug serial cable
5. launch hyper terminal (115,200 bauds, 8 bits, parity none, 1 stop bit, no flow control)
6. plug-in power supply
7. type on hyper terminal: "Alt-0128 Alt-0128 #"
8. AT91SAM9G45-EKES returns ">"
9. close hyper terminal
10. close jumper JP12 (DataFlash® Chip Select)
11. launch SAM-BA (Choose right COM port and AT91SAM9G45-EKES)
12. choose DataFlash media tab in the SAM-BA GUI interface

13. initialize DataFlash, choosing the Enable action in the Scripts rolling menu and press Execute
14. choose Send boot file, press Execute
15. select *AT91SAM9G45_RomCode_Replacement.bin* binary file and press Open; the media is written down
16. close SAM-BA

On Reset, the faulty ROM code will copy the fixed ROM code in SRAM and launch it. The connexion through USB to the SAM-BA monitor will work.
