# ***82545EM Gigabit Ethernet Controller Specification Update***

***June 6, 2006***

The *82545EM* Gigabit Ethernet Controller may contain design defects or errors known as errata that may cause the product to deviate from published specifications. Current characterized errata are documented in this Specification Update.

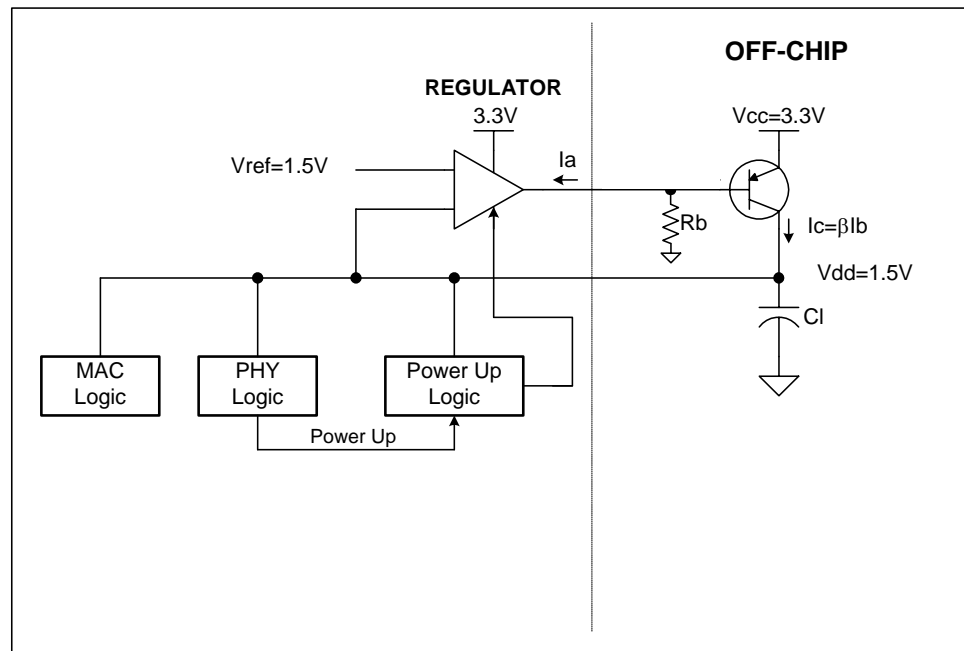
- Implication:** When drive is absent on the CTRL\_15 output, only leakage current from the CTRL\_15 output will be present. Depending on the amount of leakage current and the gain (Beta) of the external PNP transistor, there may be insufficient collector current ( $I_C = I_B * \text{Beta}$ ) to adequately supply the 1.5V rail, and the 1.5V regulator circuit may not turn on. The 1.5V rail requires a minimum collector current of 5 mA to be generated and a 1.5V rail voltage of at least 600 mV to ensure that the digital portion of the circuit turns on correctly.

When the 1.5V regulator control output fails, the 2.5V regulator control output(s) may also fail, driving the 2.5V supply toward either 0V or the 3.3V rail. The absence of one or both of the 1.5V and/or 2.5V supplies prevents the Ethernet controller from operating correctly.

- Workaround:** The regulator control output is Ball A18 on the 82545EM controller. Intel's original reference designs showed two external resistors, R1 and R2, in this circuit. The workaround completely removes R2 and replaces it with another resistor, Rb, connected between the CTRL\_15 output and ground.

Systems that generate 1.5V without using the Ethernet controller's onboard regulator control (for example, at a central power supply) do not need a workaround. No changes are required for the 2.5V regulator circuit.

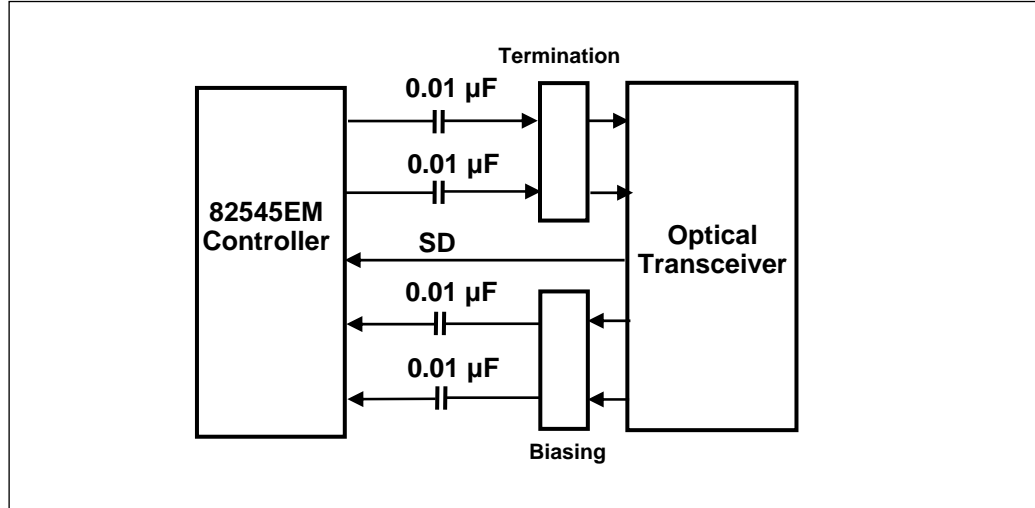
**Problem:** Intel added new SERDES functions to the 82545EM controller. SERDES stands for Serializer-Deserializer and is a circuit that converts Ethernet packet data from a parallel TBI format to a 1.25 GHz bidirectional serial stream. For 1000BASE-SX or 1000BASE-LX fiber applications, SERDES integration typically saves the designer the expense and board space of a 64-lead external device. The 82545EM controller contains one SERDES. A '10' needs to be written in ICW3 bits 1 and 0, respectively, in order to enable this feature.

The datasheet for the 82545EM Controller will change to define pins as follows:

Signal Name	Type	Name and Function
R X +/-	I	<b>SERDES Receive Pair.</b> Differential receive signal pair for 1.25 GHz serial interface. For serializer-deserializer operation, couple the inputs to ECL signal levels. If the SERDES interface is not used, leave RX +/- unconnected.
T R A N S M I T P A I R	O	<b>SERDES Transmit Pair.</b> Differential transmit signal pair for 1.25 GHz serial interface. For serializer-deserializer operation, the outputs drive LVPECL voltage levels. If the SERDES interface is not used, leave RX +/- unconnected.
S I G _ D E T E C T	I	<b>Signal Detect.</b> Indicates that a signal has been detected by an optical transceiver connected to the 1.25 GHz serial interface. If the SERDES interface is not used, connect SIG_DETECT to ground through pull-down resistors.

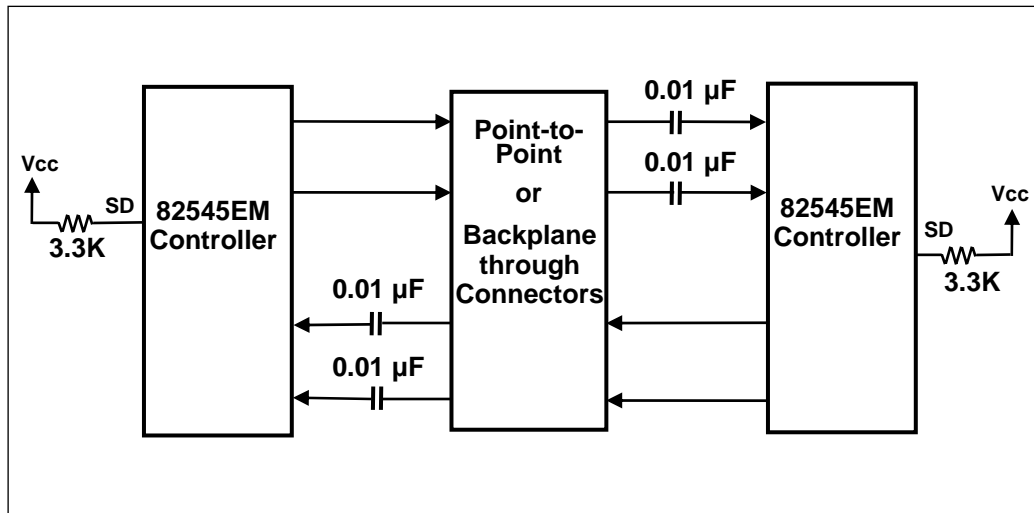
Alternatively, the 82545EM may be used in short haul gigabit backplane data applications without transceivers and optical fibers. No special termination is required because the 82545EM device is internally terminated. The figure below illustrates a gigabit backplane or point-to-point circuit based on either the 82545EM device:
