ES_LPC3240

Errata sheet LPC3240

Rev. 9 — 1 June 2011

Errata sheet

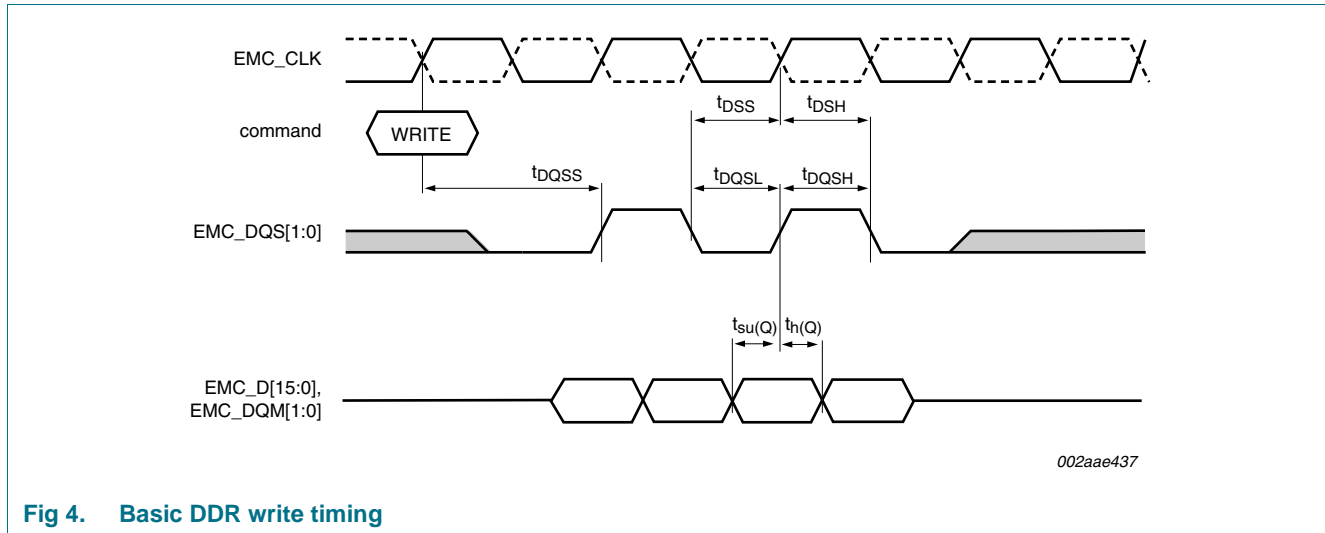
Fig 4. Basic DDR write timing

For DDR writes the LPC3240 drives the EMC_DQS[1:0] earlier in the data valid window than center aligned. With the EMC_CLK at 133 MHz this produces a minimum set-up time between the EMC_D[15:0] and EMC_DQS[1:0] of 600 ps across silicon process, voltage and temperature. Test conditions are with the EMC buffers set to fast slew rate driving 2 inches of 50 Ω transmission line and 10 pF load capacitance. DDR memories specify EMC_D[15:0] to EMC_DQS[1:0] set-up time minimum as 400 ps. This leaves 200 ps set-up time margin due to customer specific load and PCB layout implementation. See the LPC3220_30_40_50 data sheet for the complete range of DDR data output set-up time, $t_{su(Q)}$, and data output hold time $t_{h(Q)}$ times.
