XC18V00 PROM Errata and Deviations from XC18V00 Data Sheet

DS026-E01 (v1.1) March 10, 2004

Errata Notice

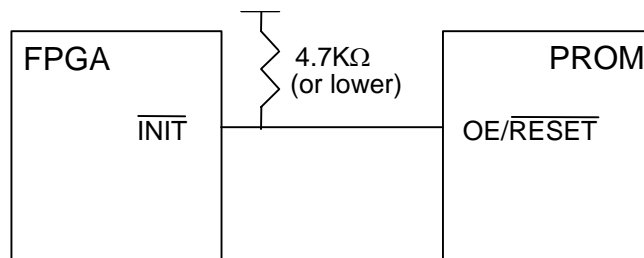
Figure 4: Recommended Resistor Value

A pull-up resistor is required to properly propagate this signal through the PROM (Figure 1). Figure 2 shows a clean OE/RESET# (INIT#) signal. However, a slow ramp could potentially allow system noise to propagate through the PROM's input buffer (Figure 3), thus creating short reset pulses that might cause the internal circuits to get out of sync. The observed failure rate ranges from 1% to 5% of configuration cycles.

Follow the data sheet to ensure that an external 4.7KΩ (or lower) resistor is connected to the PROM's OE/RESET# pin and the FPGA's INIT pin. Ensure that the FPGA T_{ICCK} specification is met (500ns). This translates to a T_{RISE} and T_{FALL} time of 500 ns for the PROM's OE/RESET# signal.

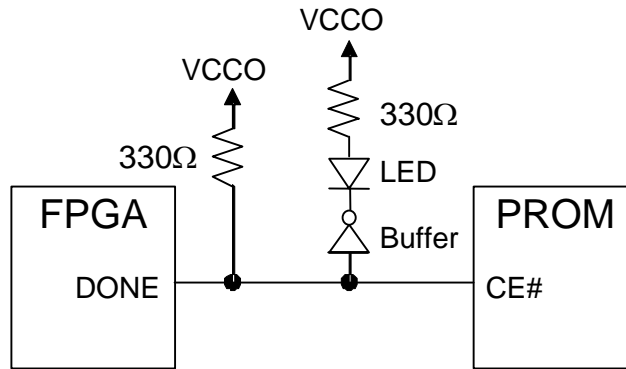
Figure 8: (LED with Buffer Circuit)

The FPGA has a sink current specification of 12 mA that is exceeded when an unbuffered LED is tied to the CE# (DONE) signal (Figure 5). In this scenario, the CE# (DONE) signal is held at an intermediate voltage level that mimics multiple input pulses (Figure 7). These pulses propagate through the PROM and cause the internal circuits to get out of sync. The observed failure rate is up to 50% of configuration cycles. Figure 6 shows a clean CE# (DONE) signal when it is not tied to an LED.

When using FPGA DONE to drive PROM CE# (to reduce standby power), make sure that the signal is within the specification and has a fast rise and fall time. Use an external buffer to drive any LED (Figure 8). If DONE is not used to drive CE#, it can be connected to an LED (Figure 9).

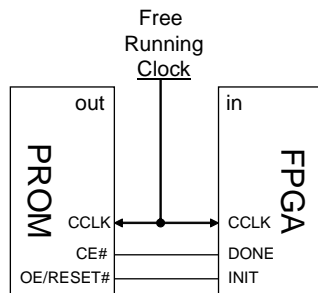
Figure 10: Asynchronous System

In most applications, the FPGA sources the CCLK signal, which synchronizes with the CE# (DONE) and OE/RESET# (INIT#) signals. However, in an asynchronous system (Figure 10), meaning when an external free-running clock drives the configuration clock signal (CCLK), there is a possibility that a missed or extra pulse (or pulses) can be interpreted by the PROM's internal counters as CCLK transitions while the OE/RESET# (INIT#) signal is in its intermediate phase (Figure 11). The observed failure rate ranges from 0.1% to 1% of configuration cycles.

There is no application work-around that will avoid exposure to the phenomenon when a free running clock is used. Therefore, customers who are using an external free-running clock need to convert their ordering code to SCD0799; this will ensure that they will not receive affected devices identified in Table 1, Table 2, and Table 3.

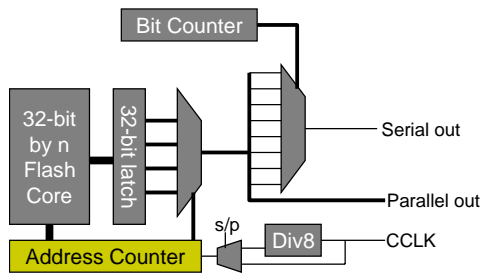
Figure 14: Counter Circuits

The Address Counter misses the first increment and repeats the first 32 bits. Table 4 (above) summarizes the conditions where an Extra 32 Bits pattern can occur.
