## Errata Sheet V1.0

### 9. Warning: Additional NWAIT Constraints

AT91  
ARM® Thumb®  
Microcontrollers

AT91M42800A  
Errata Sheet  
V1.0

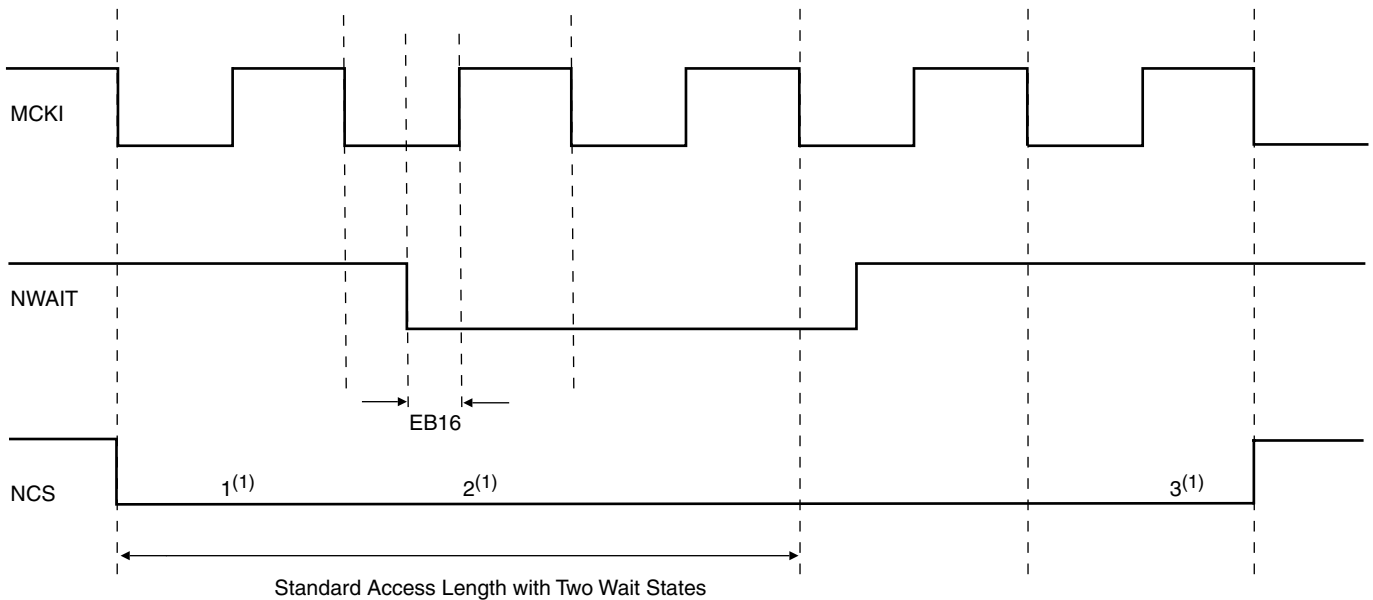
**Figure 2. Number of Standard Wait States is Two**

If the NWAIT setup time is satisfied on the following edges of MCKI and if at least one standard wait state remains to be executed, the behavior is accurate. In the following example, the number of standard wait states is two. The NWAIT setup time on the second rising edge of MCKI must be met.

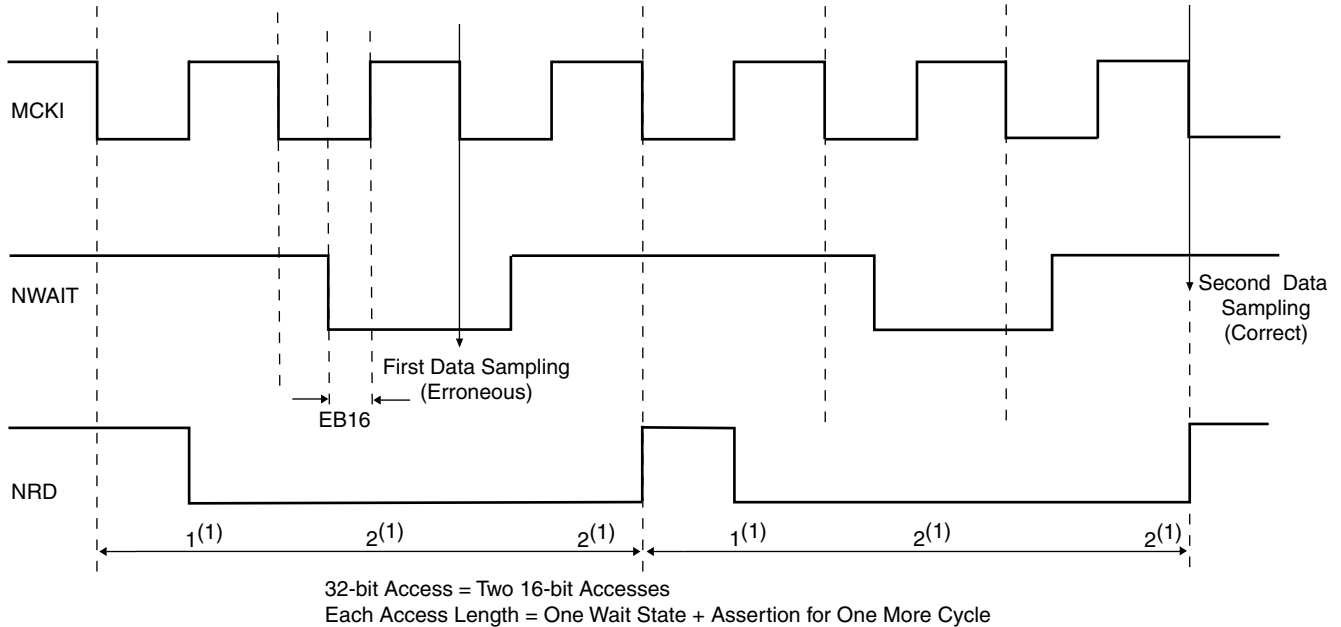
**Figure 3.** Number of Standard Wait States is One

If the first two conditions are not met during a 32-bit read access, the first 16-bit data is read at the end of the standard 16-bit read access. In the following example, the number of standard waits is one. NWAIT assertions do affect both NRD pulse lengths, but first data sampling is not delayed. The second data sampling is correct.

At maximum speed, asserting the NWAIT in the first access cycle is not possible, as the sum of the timings “MCKI Falling to Chip Select” and “NWAIT setup to MCKI rising” are generally higher than one half of a clock period. This leads to using at least one standard wait state. However, this is not sufficient except to perform byte or half-word read accesses. Word and write accesses require at least two standard wait states.
