Errata and Added Information to MC68360 Quad Integrated Communication Controller User's Manual Rev 1

January 8, 1998

This document describes the latest information and changes to the first revision of the MC68360 user's manual.

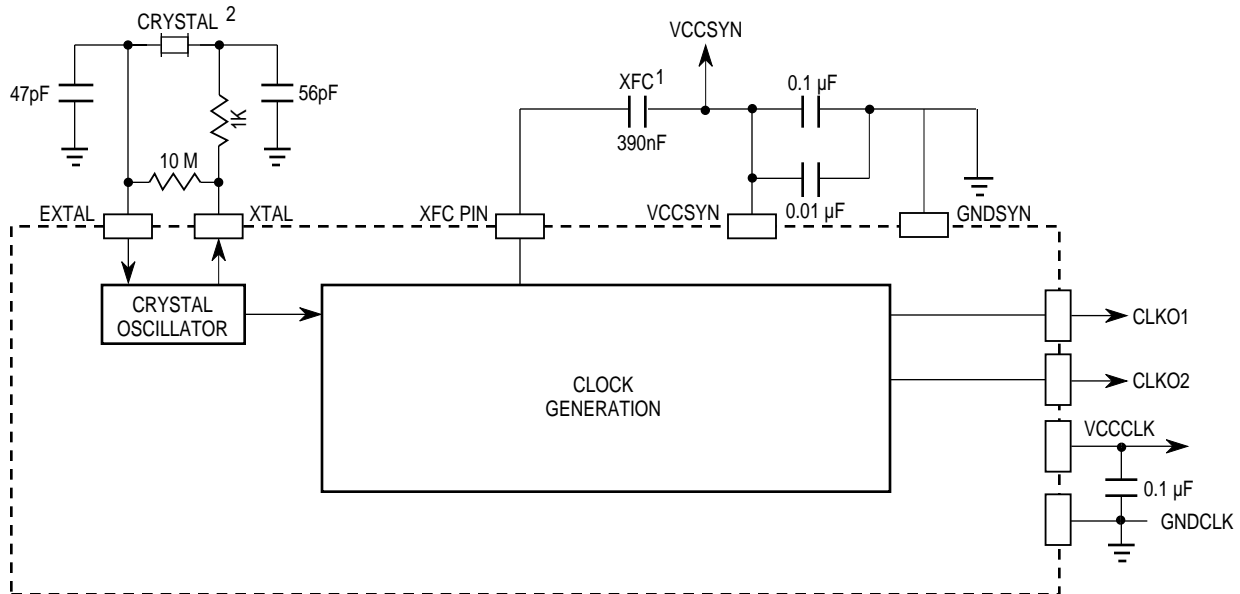
Figure 6-6A External Components for 4.192MHz

Also on page 6-14 the following figure should be added.

1. Must be low-leakage capacitor. See Section 10 Electrical Characteristics for recommended values.
2. Values are for 4.194MHz crystal and may vary due to capacitance on PCB.

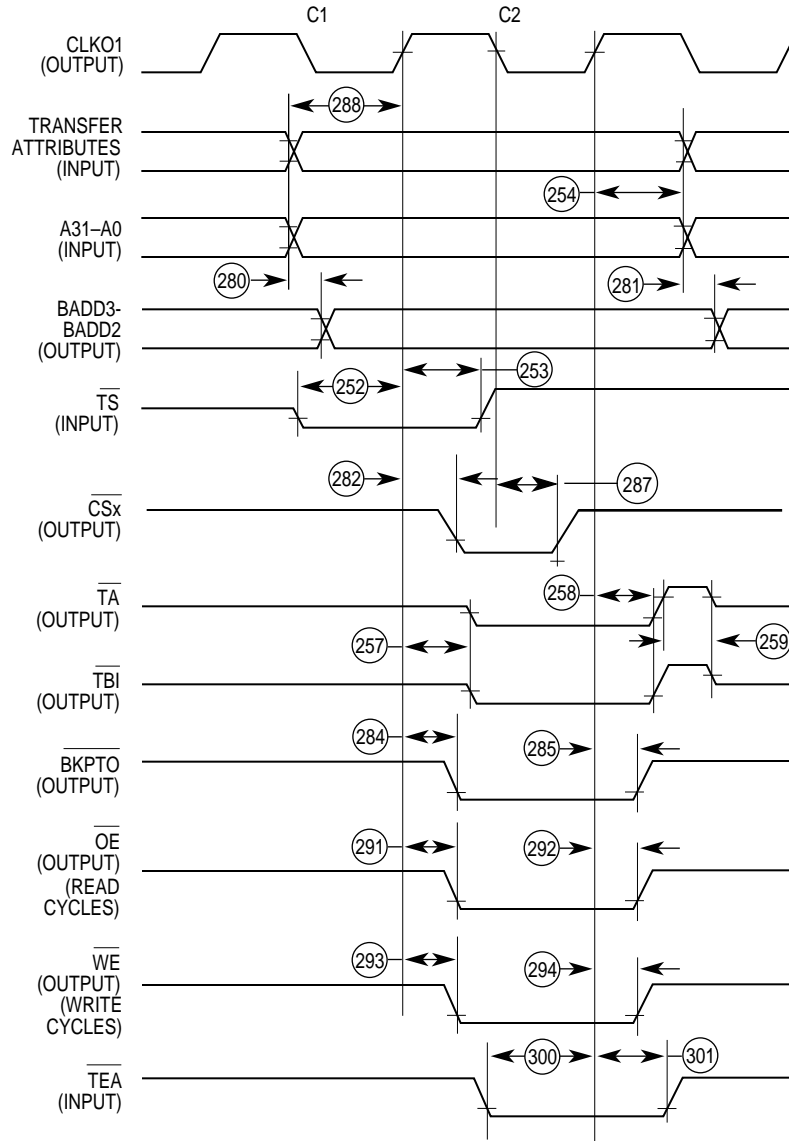
Figure 10-44(b) MC68040/EC040 SRAM Write cycle (TSS40=0, CSNT40=1)

The following figure should be added after figure 10-44(a)

NOTE: MC68040 Transfer Attribute Signals = SIZx, TTx, TMx, R/W, LOCK

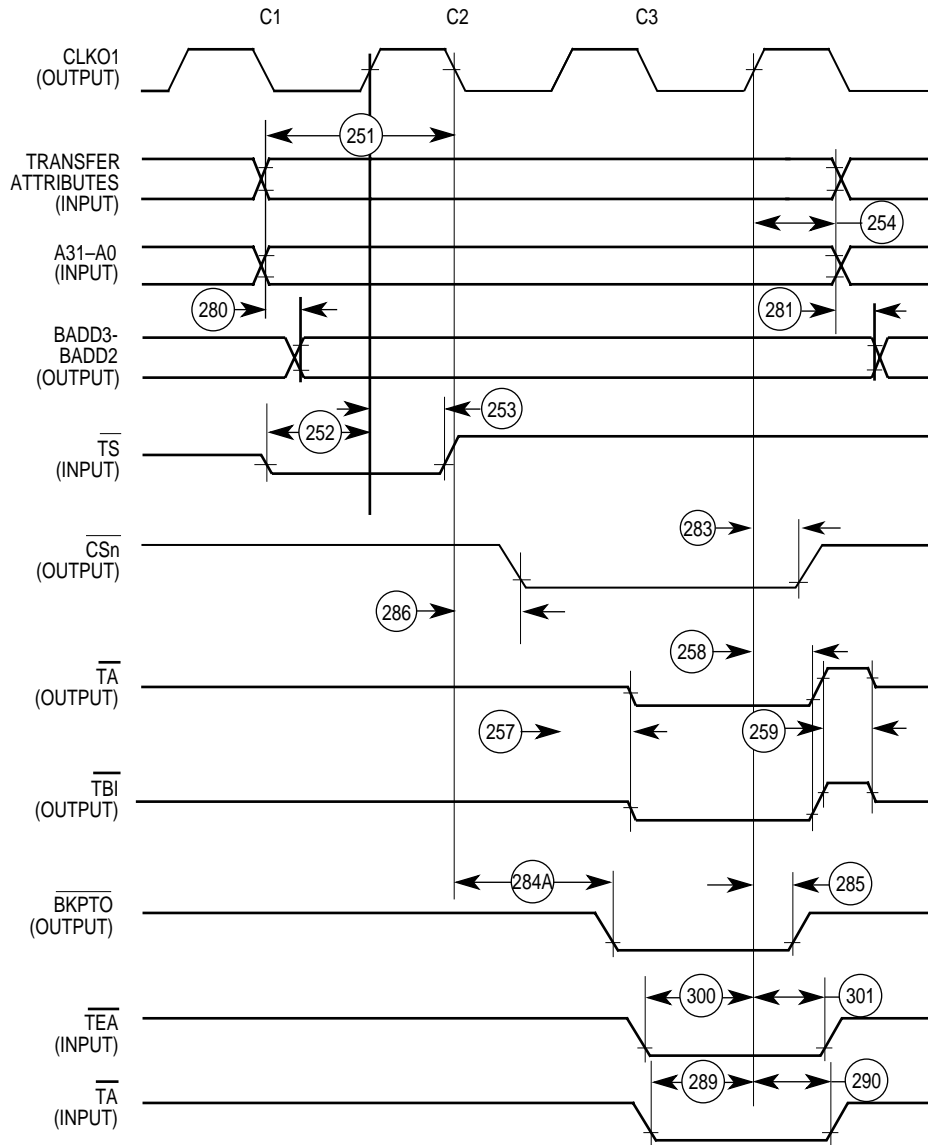
Figure 10-45(b) MC68040/EC040 SRAM Read Cycle (TSS40=1, CSNT40=1)

\overline{OE} and \overline{WE} signals are not supported when TSS40 is set to 1.

The following figure should be added below figure 10-45(a)

NOTE: MC68040 Transfer Attribute Signals = SIZx, TTx, TMx, R/W, LOCK
OE and WE are not supported when TSS40 is set to 1
