TR0636E-20033

IT3D(M)-300S-BGA (57) Cross Sectioning
TEST REPORT

To evaluate SnCu intermetallic at BGA joints by cross sectioning initial state and post 3500 thermal cycle in accordance with IPC-9701.

TR0636E-20033 - IT3 CROSS SECTIONING Analysis

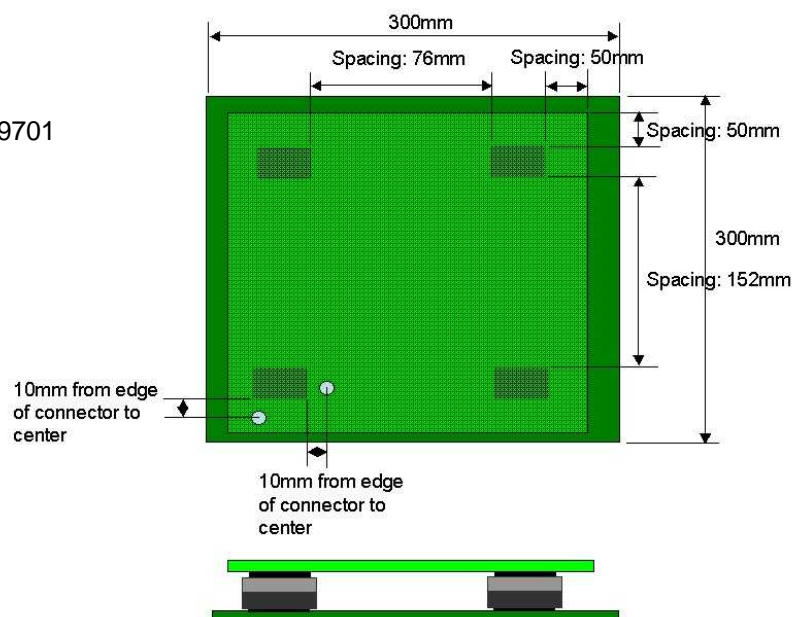
Fig.1

- *Specimens are assembled as Fig.1.
- *The test board design is based on IPC-9701 specification.
- *Thickness of the PCB: 3.3mm

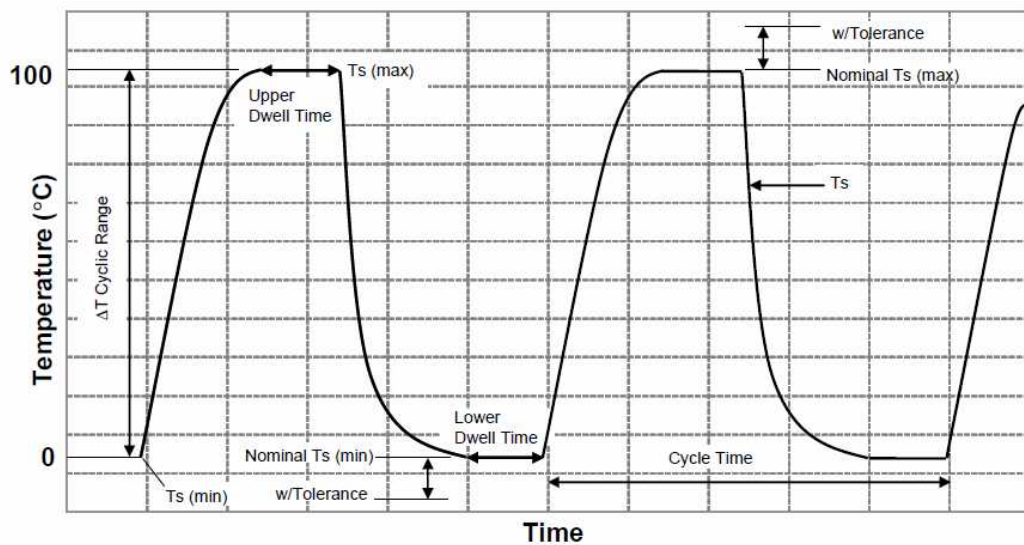
- Thermal cycle profile
 - $T_{\max} = 100\text{ }^{\circ}\text{C}$ (+10 / 0 $^{\circ}\text{C}$)
 - $T_{\min} = 0\text{ }^{\circ}\text{C}$ (0 / -10 $^{\circ}\text{C}$)
 - Ramp rate = Approximately 10 $^{\circ}\text{C}/\text{min}$ (10% to 90% of test temperature range)
 - Dwell time = 5 to 10 min (Holding time of maximum and minimum temperature)

- Test cycle : 3500 cycles

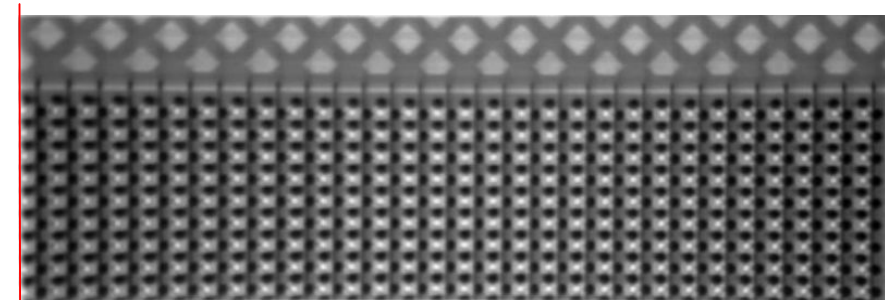
2-2 Cross Sectioning Locations

1st Column of Solder Joints

Pin 1 Side

1st Row of Solder Joints

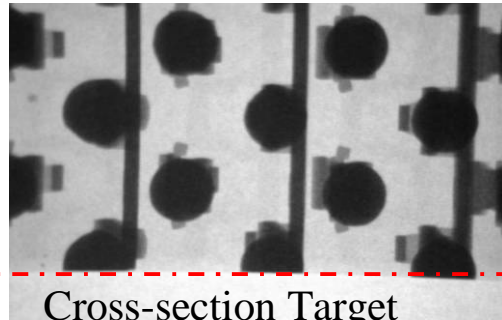
X-Ray Image

No.1 SnPb Raw Connector

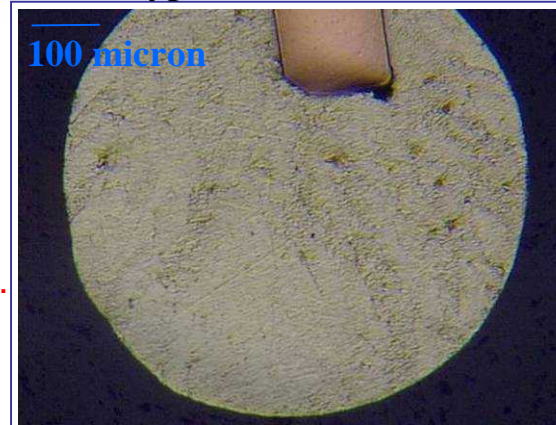
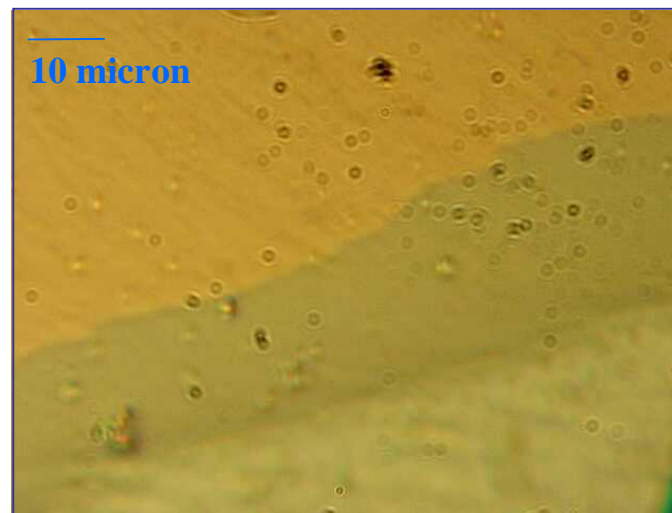
Typical Solder Joint

Pin

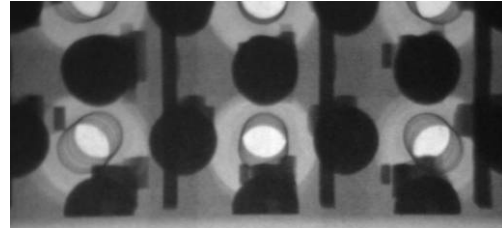
X-Ray Image

No.2 /IT3M-300S-BGA(57) / Virgin / Initial SnPb_MB_026 Conn-2

Cross-section Target

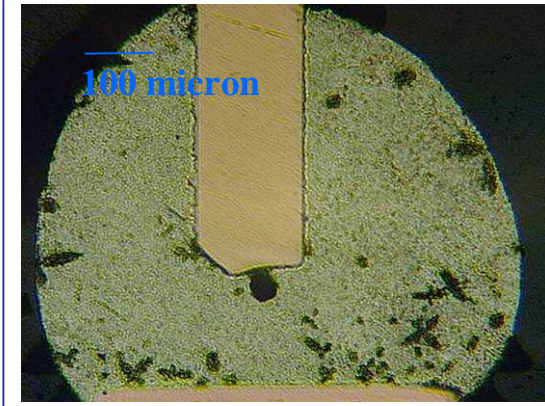
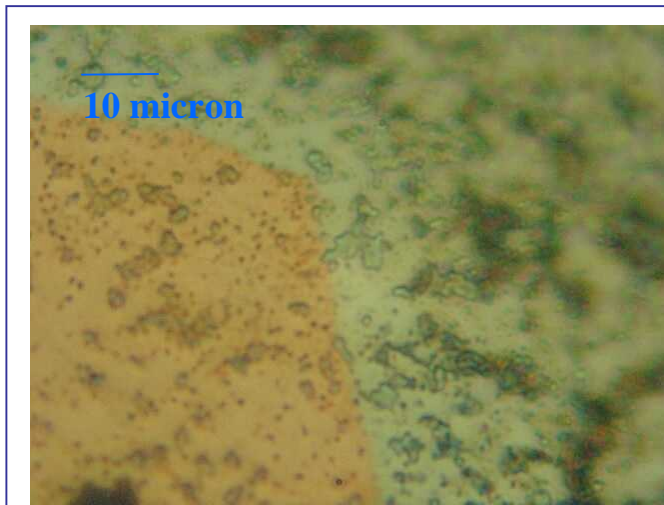
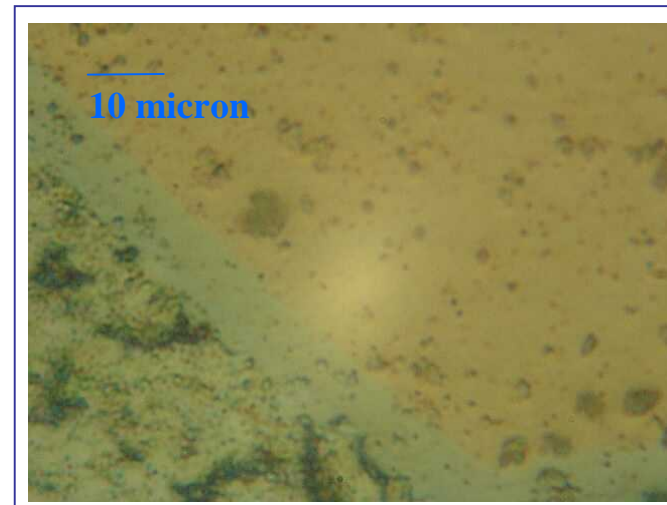
Typical Solder Joint

PCB

Pin

Typical SnCu intermetallic was observed in all specimens.

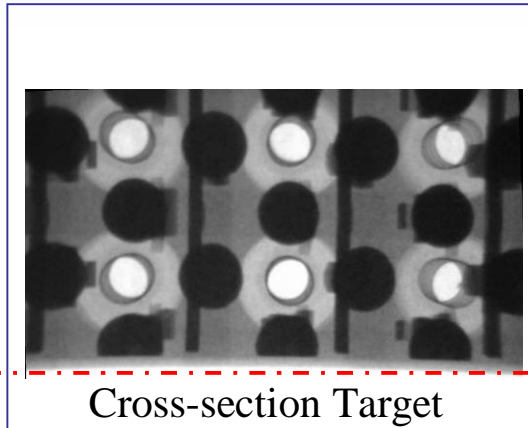
X-Ray Image

No.3 /IT3M-300S-BGA(57) / Reworked / Initial SnPb_MB_026 Conn-1

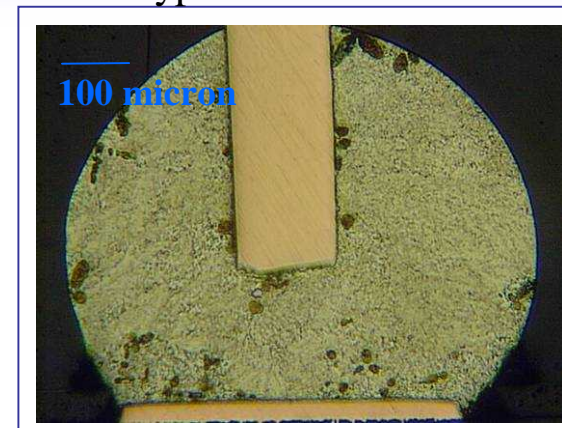
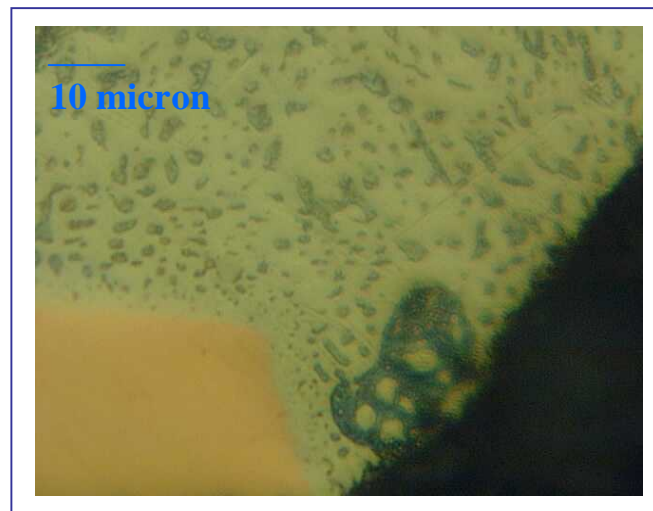
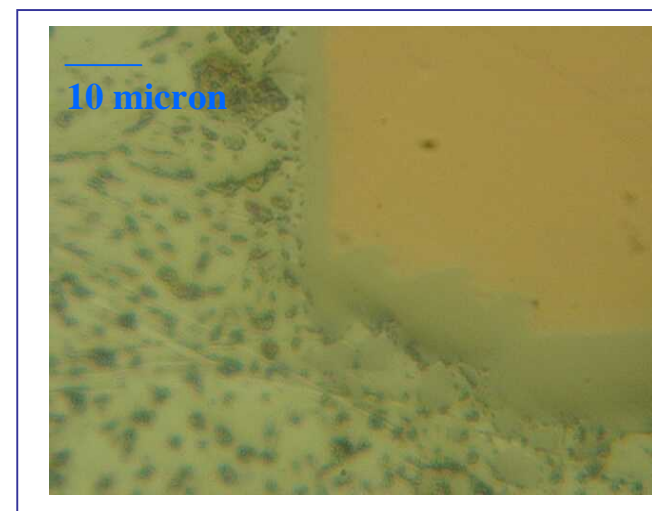
Typical Solder Joint

PCB

Pin

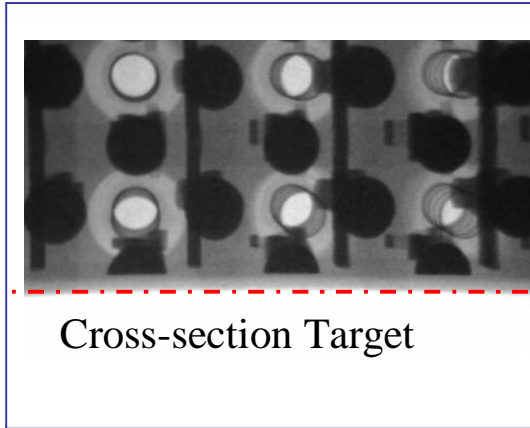
X-Ray Image

No.4 /IT3D-300S-BGA(57) / Virgin / Initial SnPb_DC_027 Conn-2

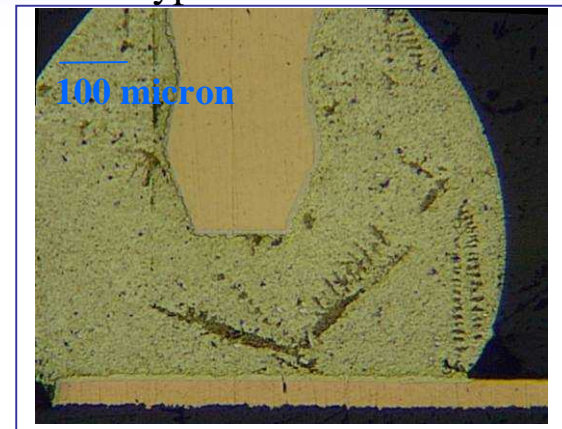
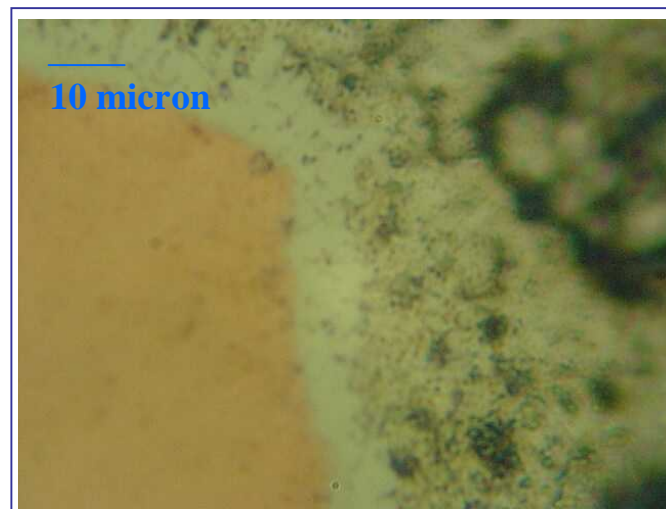
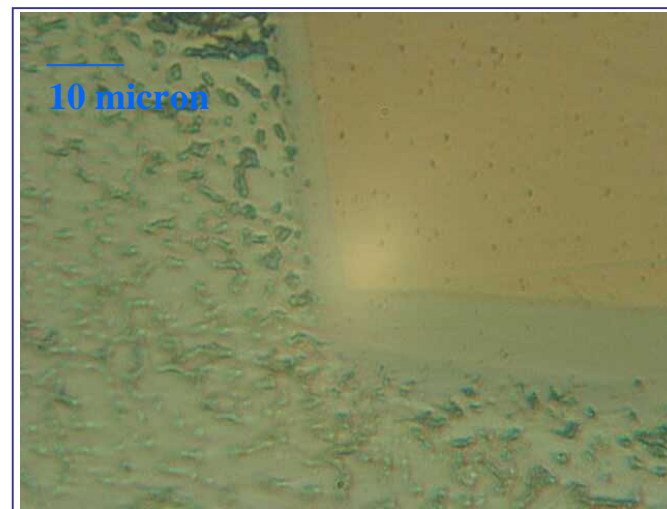
Typical Solder Joint

PCB

Pin

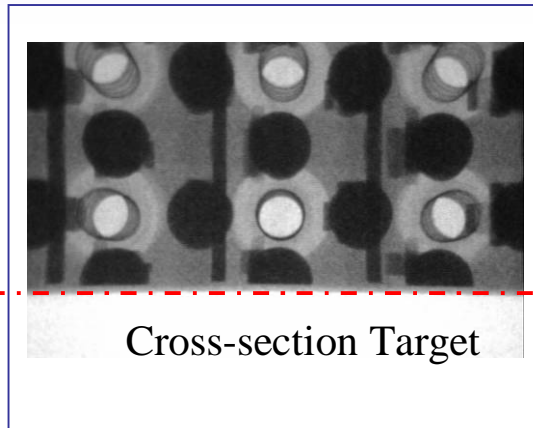
X-Ray Image

No.5 /IT3D-300S-BGA(57) / Reworked / Initial SnPb_DC_027 Conn-1

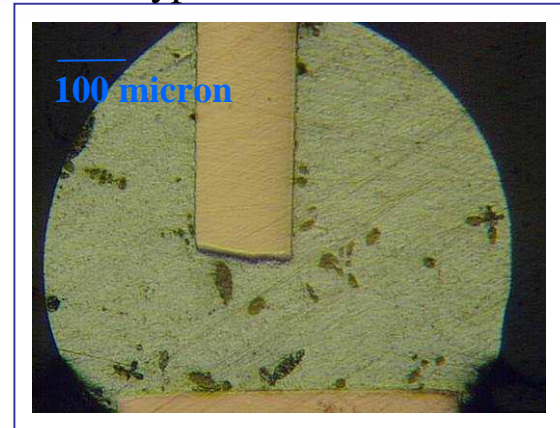
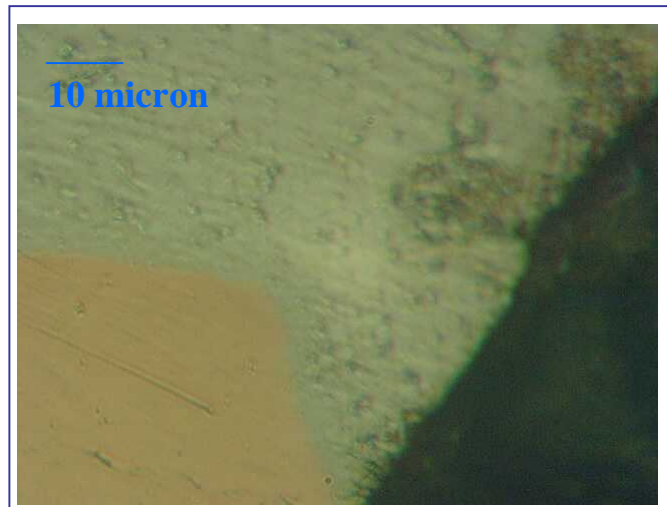
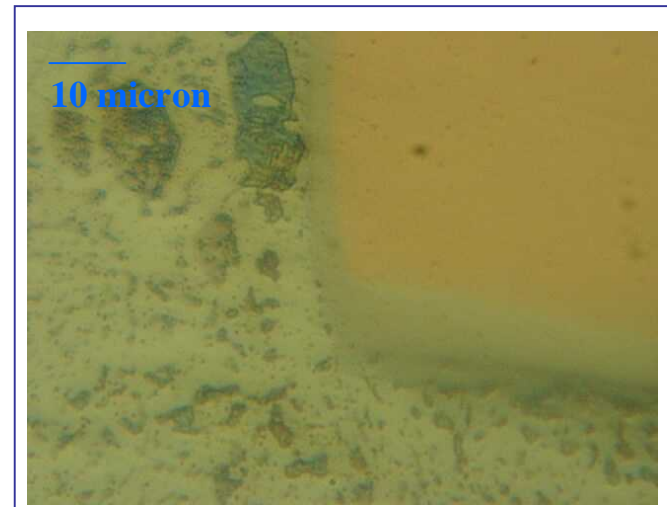
Typical Solder Joint

PCB

Pin

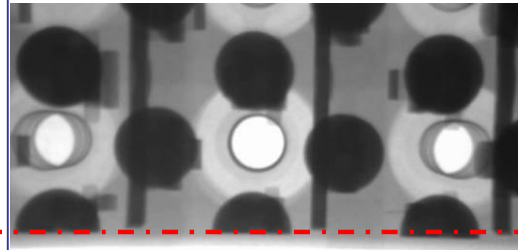
X-Ray Image

No.6 /IT3M-300S-BGA(57) / Virgin / Post 3500 cycles SnPb_MB_027 Conn-2

Cross-section Target

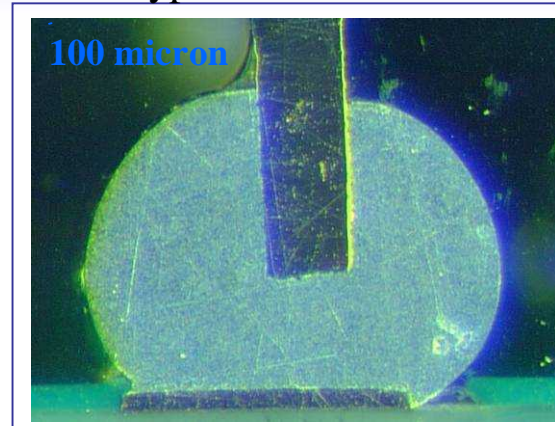
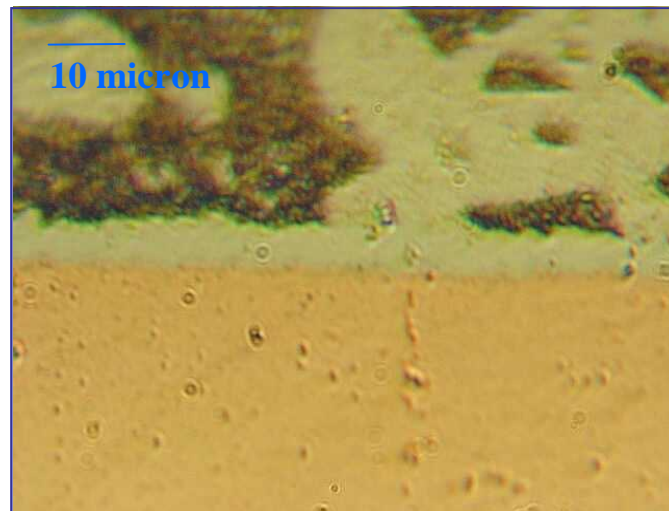
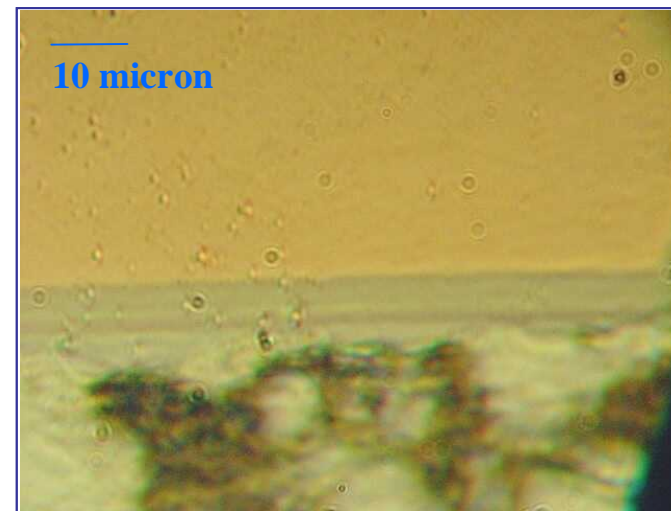
Typical Solder Joint

IMC - PCB

IMC - Pin

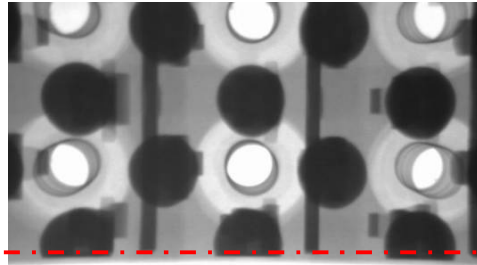
X-Ray Image

No.7 /IT3M-300S-BGA(57) / Reworked / Post 3500 cycles SnPb_MB_027 Conn-1

Cross-section Target

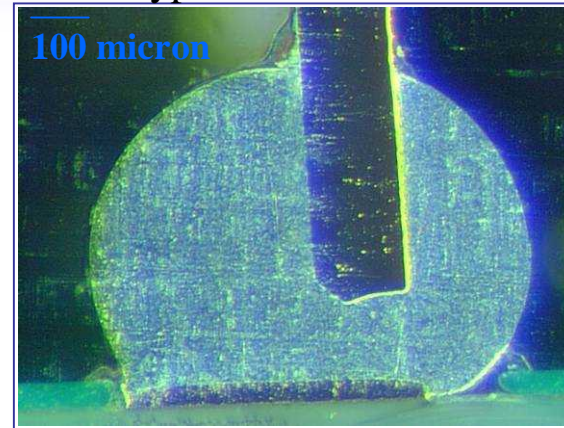
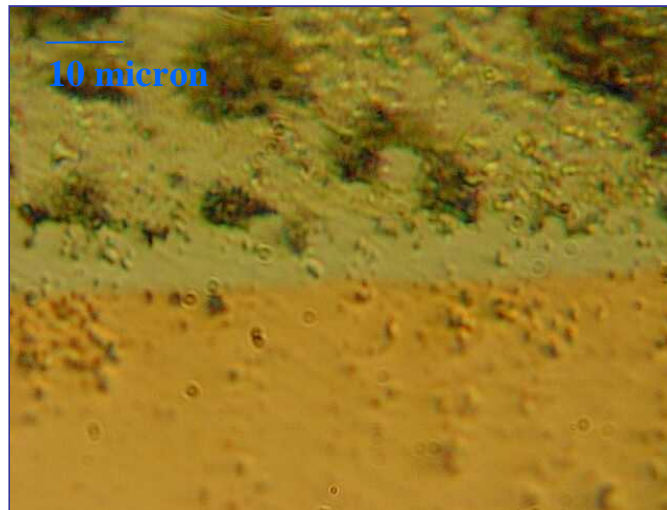
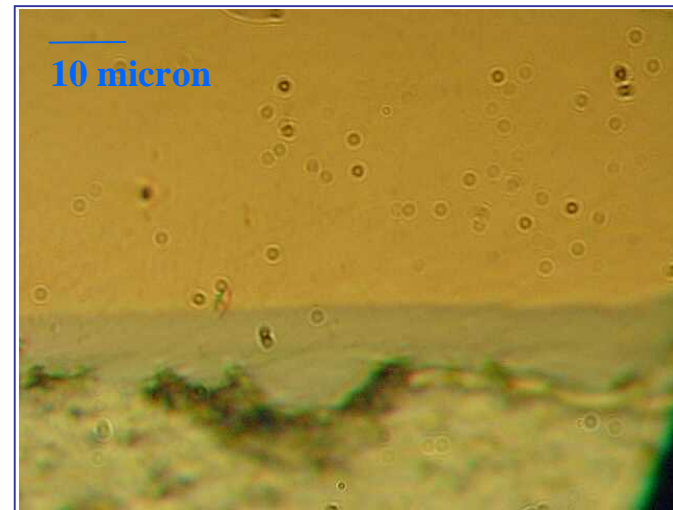
Typical Solder Joint

IMC - PCB

IMC - Pin

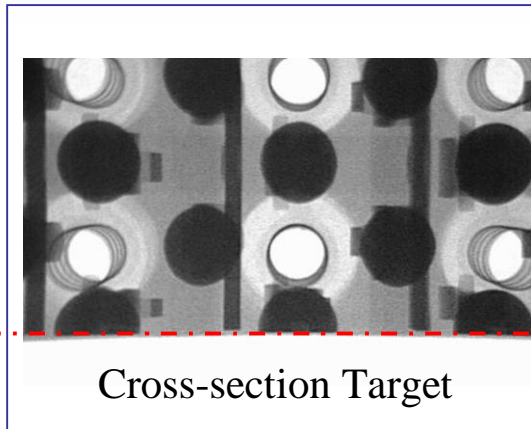
X-Ray Image

No.8 /IT3D-300S-BGA(57) / Virgin / Post 3500 cycles SnPb_DC_026 Conn-2

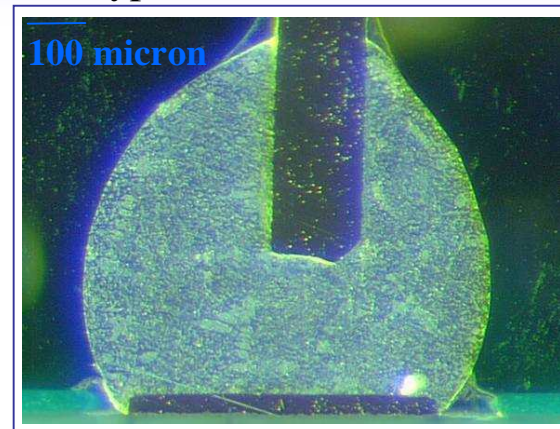
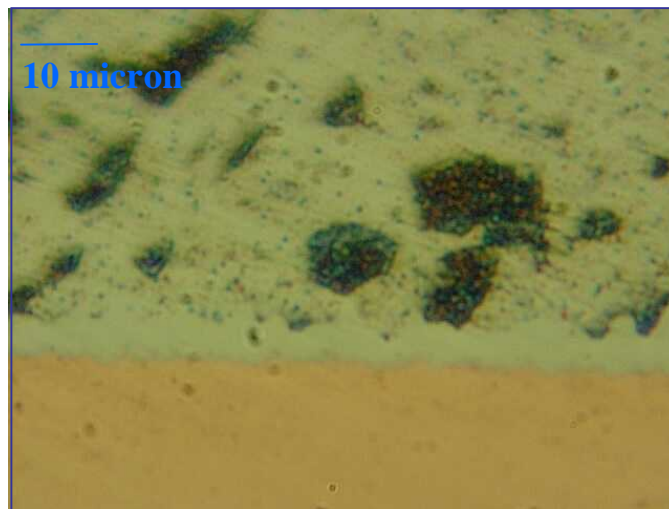
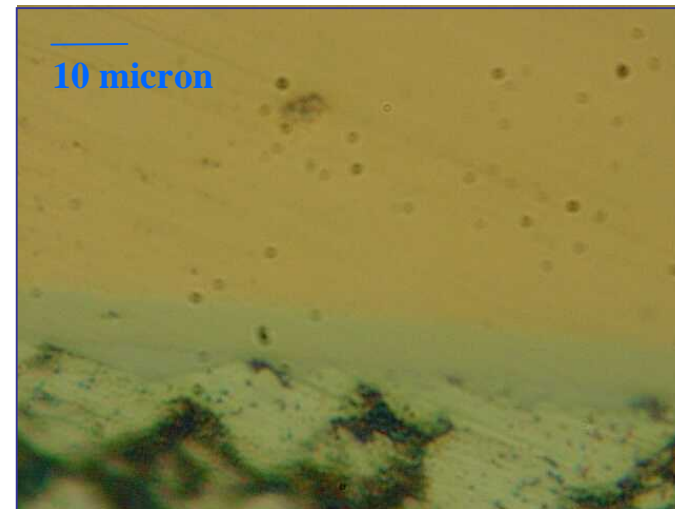
Typical Solder Joint

IMC - PCB

IMC - Pin

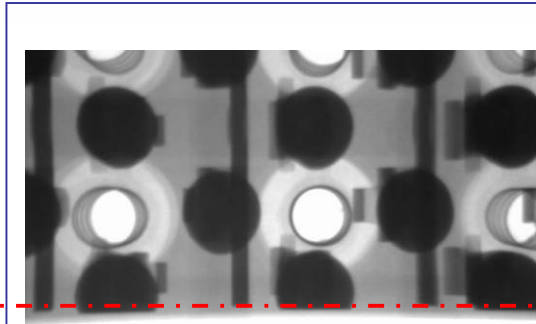
X-Ray Image

No.9 /IT3D-300S-BGA(57) / Reworked / Post 3500 cycles SnPb_DC_026 Conn-1

Cross-section Target

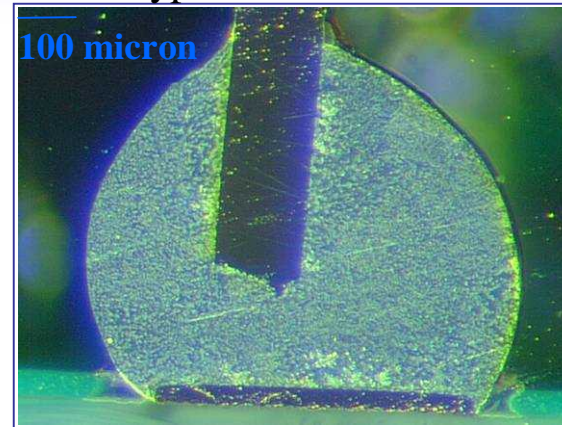
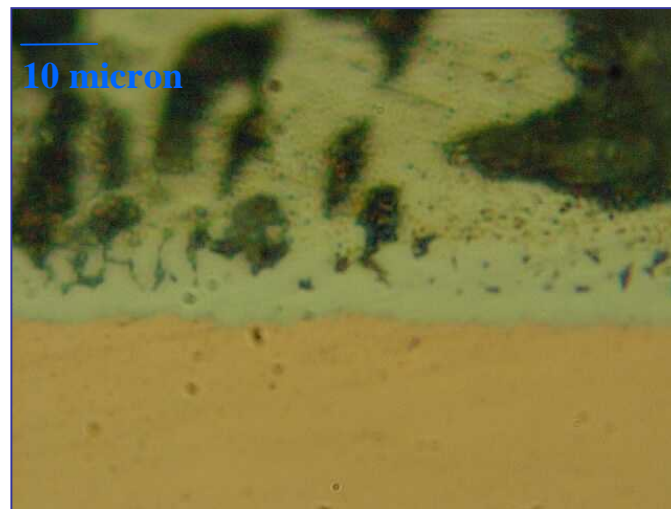
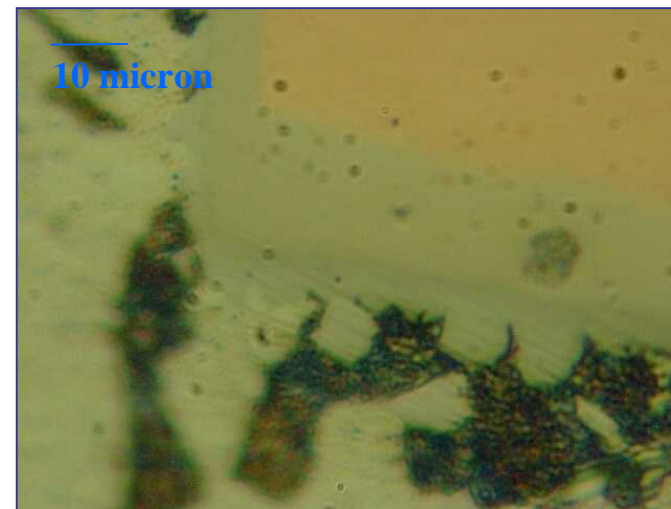
Typical Solder Joint

IMC - PCB

IMC - Pin
