PM5313

SPECTRA-622

**SONET/SDH PAYLOAD
EXTRACTOR/ALIGNER**

REVISION B DEVICE ERRATA

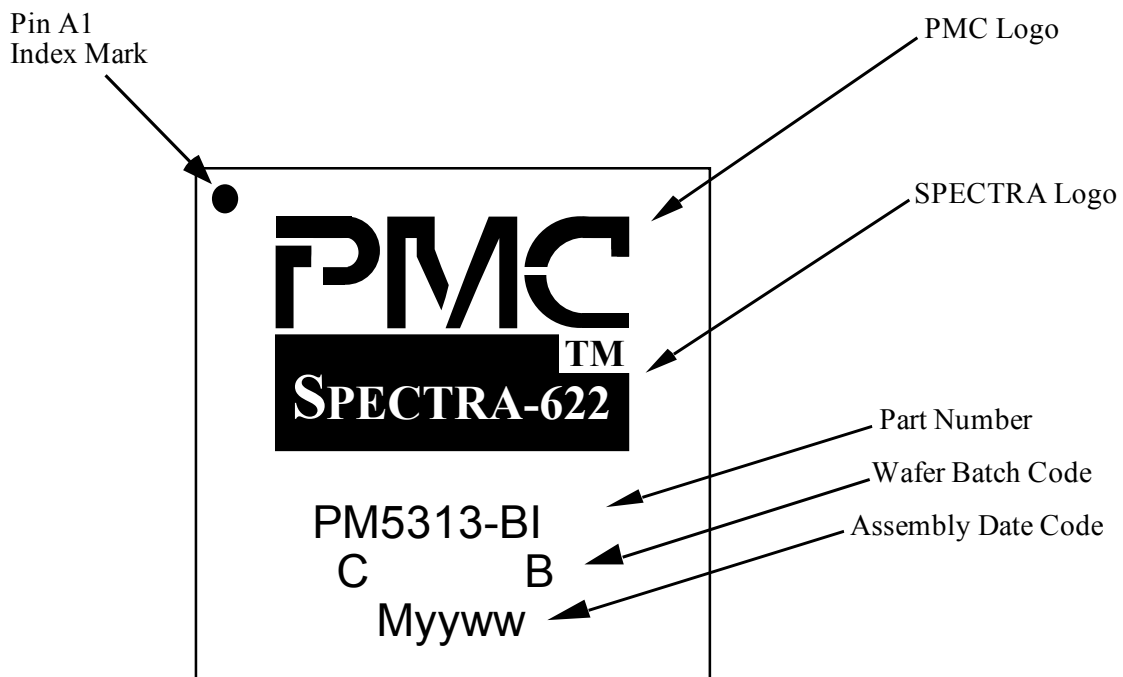
Figure 1: PM5313 SPECTRA-622 Branding Format

The information in this document applies to the PM5313 SPECTRA-622 revision B device only. The device revision code is marked at the end of the Wafer Batch Code on the face of the device (as shown in Figure 1). PM5313 SPECTRA-622 Revision B is packaged in a 520 pin Super BGA package.

TOP VIEW
SCALE : 2:1
(APPROX.)
