**PM5315**

**SPECTRA-2488™**

**SONET/SDH Payload Extractor/Aligner**

**Errata**

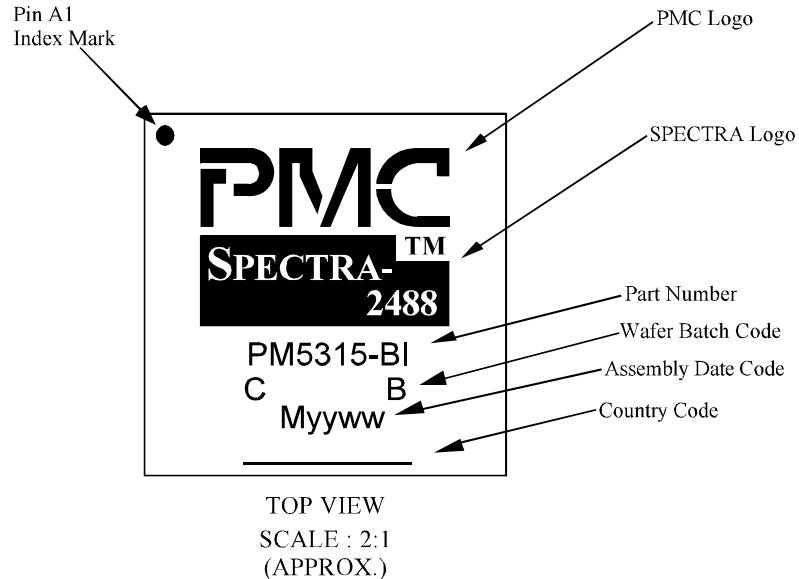
**Figure 1 PM5315 SPECTRA-2488 Branding Format**

The information in this document applies to revision B of the PM5315 SPECTRA-2488 device only. The device revision code is marked at the end of the Wafer Batch Code on the face of the device (as shown in Figure 1). PM5315 SPECTRA-2488 Revision B is packaged in a 520-pin Super-BGA package.
