ERRATA SHEET

Date: November 01, 2001
Document Release: Version 1.0
Devices Affected: P89C660, P89C662, P89C664, P89C668
(referenced to as P89C66x in this document)

On-chip Flash 8-bit microcontroller Errata Sheet

P89C66x

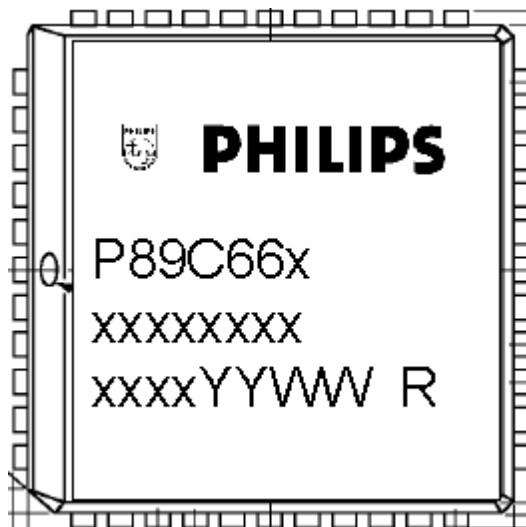
The P89C66x devices have the following top-side marking (PLCC44 package shown):

The last letter in the third line (field 'R') will identify the device revision. This Errata Sheet covers the following revisions of the P89C66x:

Field 'YY' states the year the device was manufactured. Field 'WW' states the week the device was manufactured during that same year.
