PM7351 S/UNI-VORTEX

OCTAL SERIAL LINK MULTIPLEXER

**DEVICE ERRATA**

**ISSUE 4: JUNE 2000**

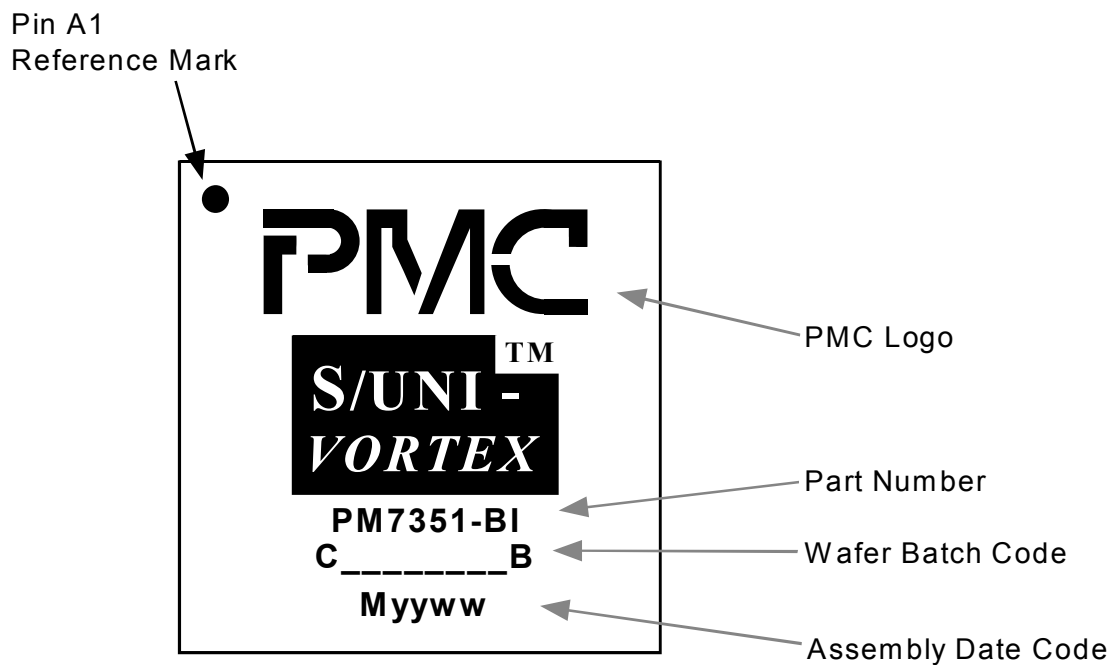
**Figure 1 – Device Marking**

The information contained in this document applies to Revision B of PM7351 S/UNI-VORTEX only. The device revision code is marked at the end of the Wafer Batch Code on the face of the device (as shown in Figure 1).

**SCALE = 2:1 (Approx.)**
